# SMRID Infrastructure:

# Main Canal Structure Maintenance:

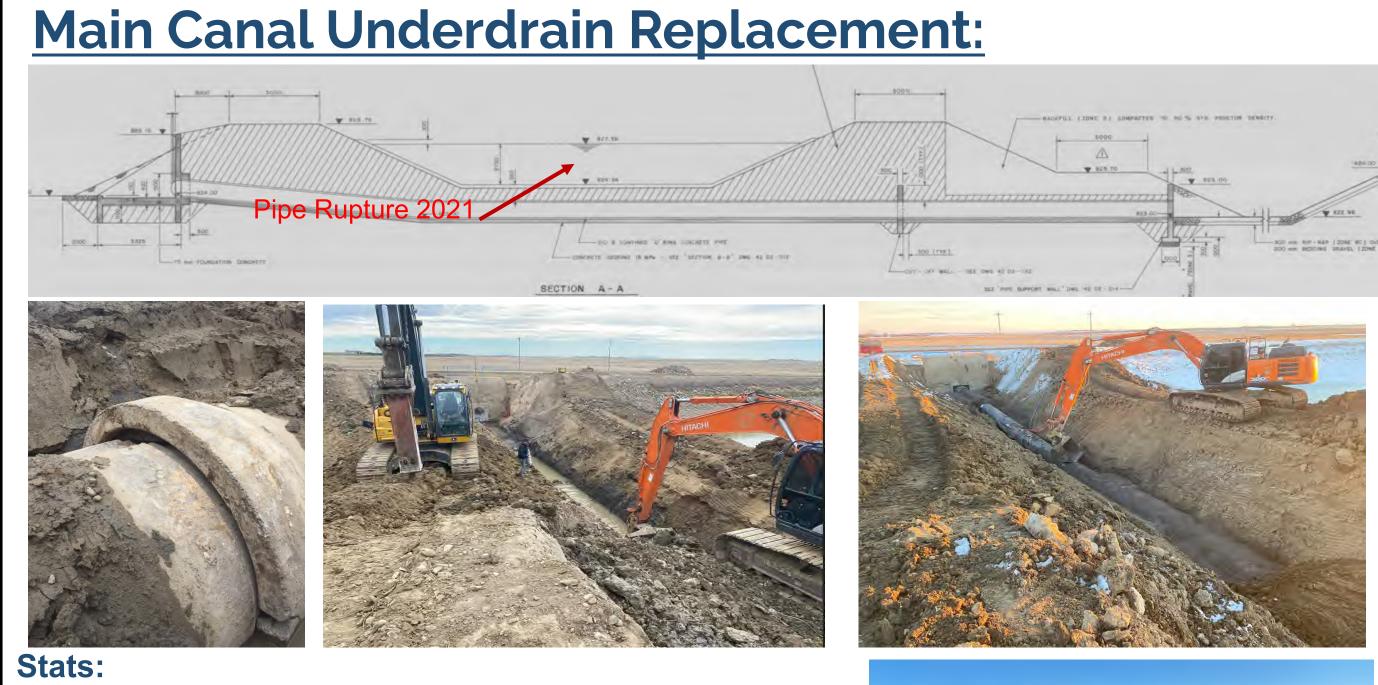
- 42" Reinforced concrete pipe cross drain installed in 1987
- Failure was noted 1 week prior to 2021 startup Total Cost of Replacement \$500,000

- Replaced with 42" HDPE Pipe
- Design Life 50 years
- Contractor: Dennis Dirtworx Ltd.

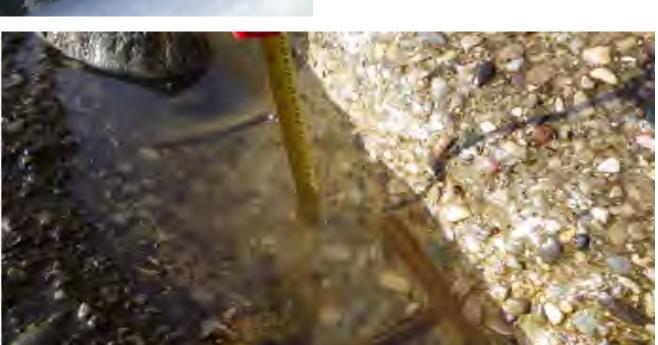
Exposed rebar caused by erosion up to 100 mm deep on basin slab downstream of weir, Oct. 23, 2019

Roughly **\$400,000 to \$600,000** of concrete maintenance required

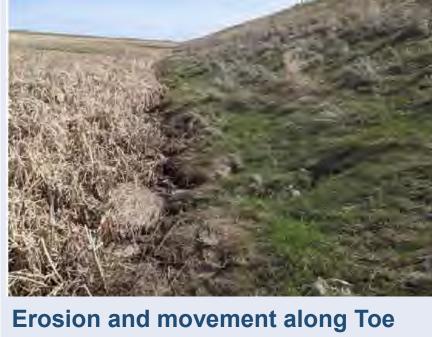
The 2024 Dam Safety Review identified the downstream slope has a factor of safety of 1.2; should be at minimum, 1.5

- Drilling investigation planned for 2025 to evaluate stability of the dam ~\$150,000
- Resulting rehabilitation could range up to \$2-3 Million

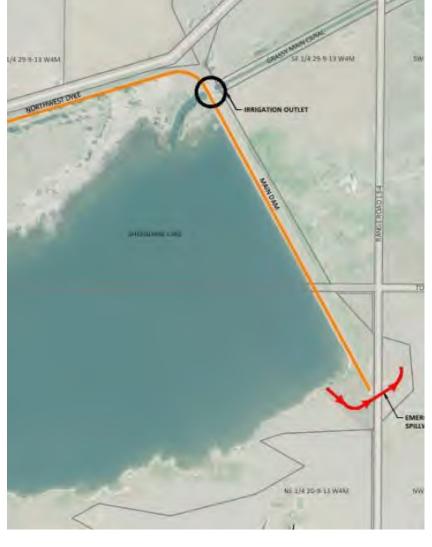
Downstream slope: uneven surface

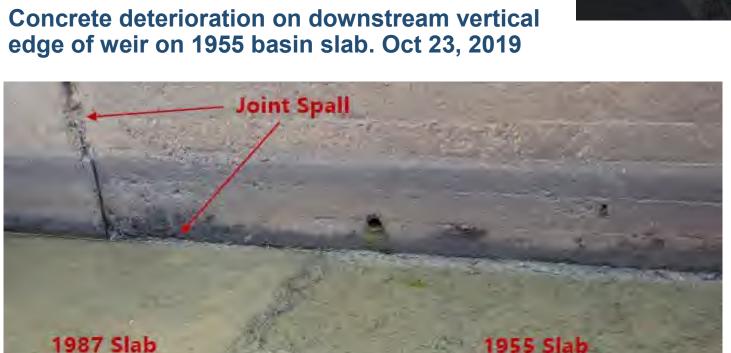
Drop 13: Drop looking upstream from left canal bank. Oct. 23, 2019
