North Burdett

Remaining Concrete Canals

Buried Steel Components of Pipelines

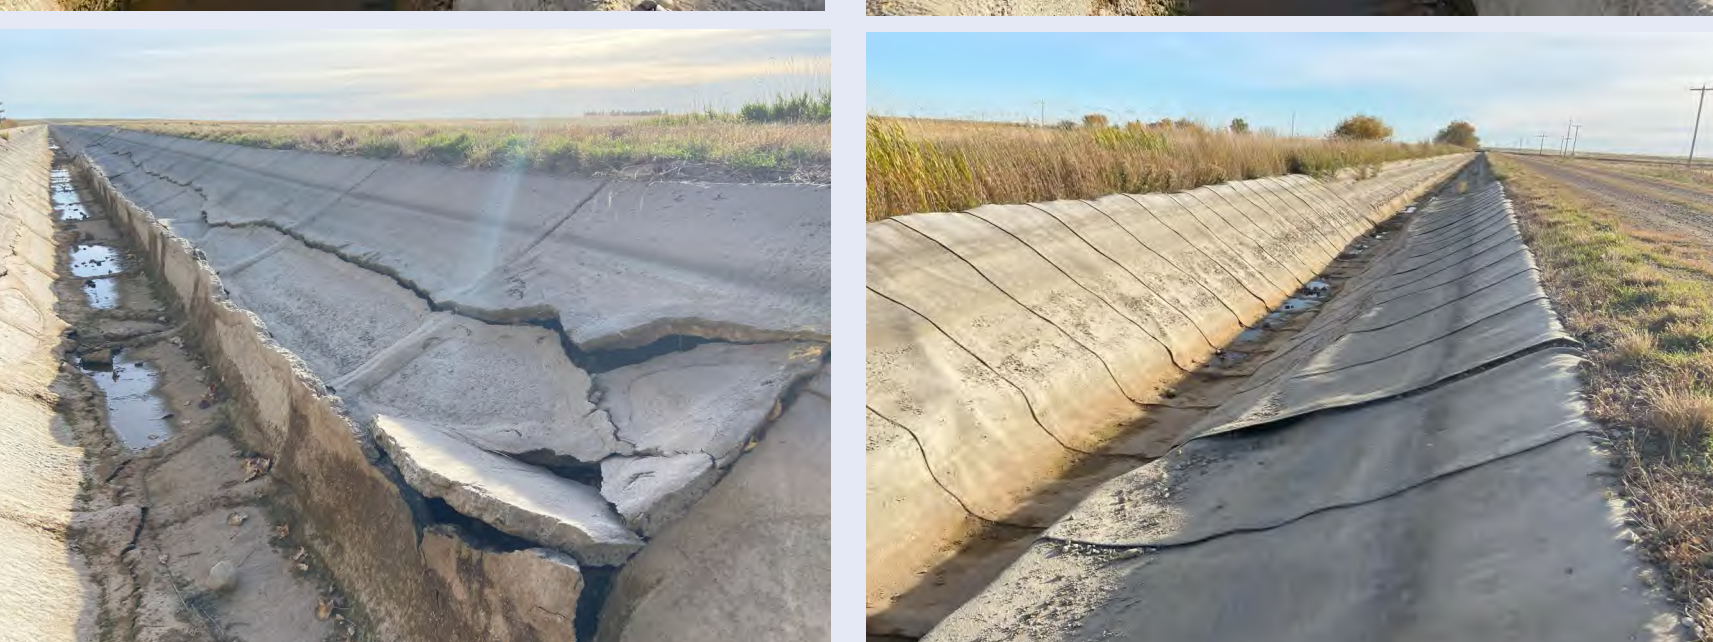
Tried "Concrete Canvas"

- 1970s Construction
- Flow Rate 3.8 m³/s
- Poor Condition
- Preliminary Cost of Replacement: \$10–\$20 Million.

- No funding source identified to renew system at this time. Buried pipe likely not feasible.
- **\$450,000 over at least 3 years for needed repairs.**

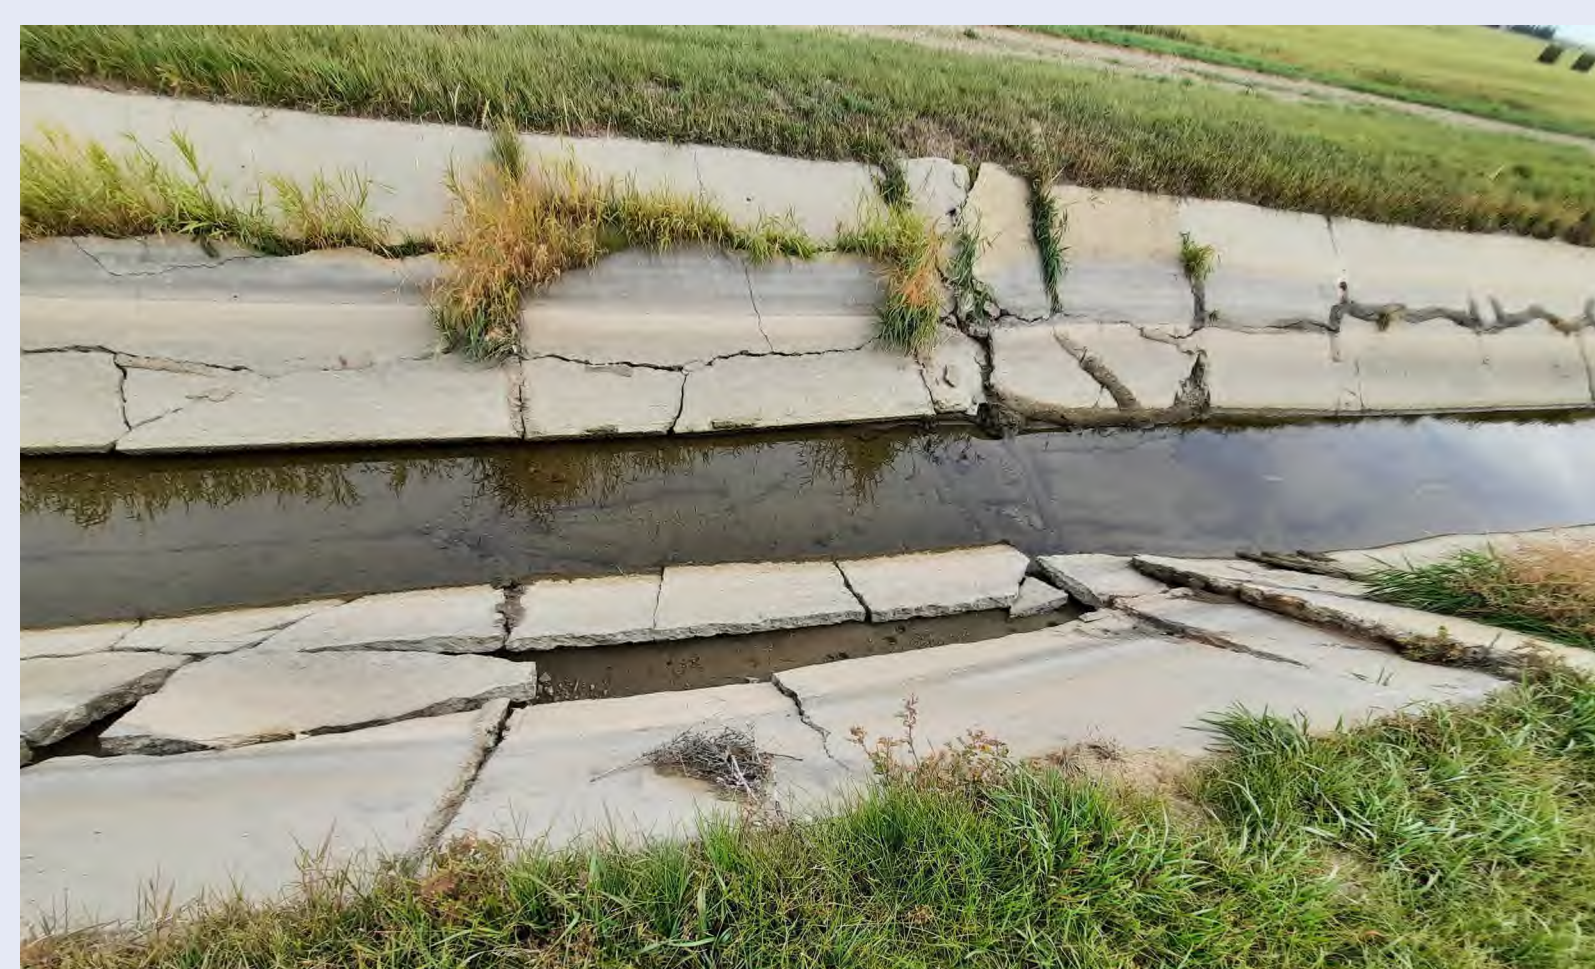
- 1970s canal construction of which 2 km is concrete lined in poor condition, with a flow rate of 2.8 m³/s.
- Patching but a more intensive rehabilitation required.
- Anticipated Cost of Concrete Canal Replacement: **\$3M**
- Preliminary Cost of Pipeline Replacement: **\$25 Million**

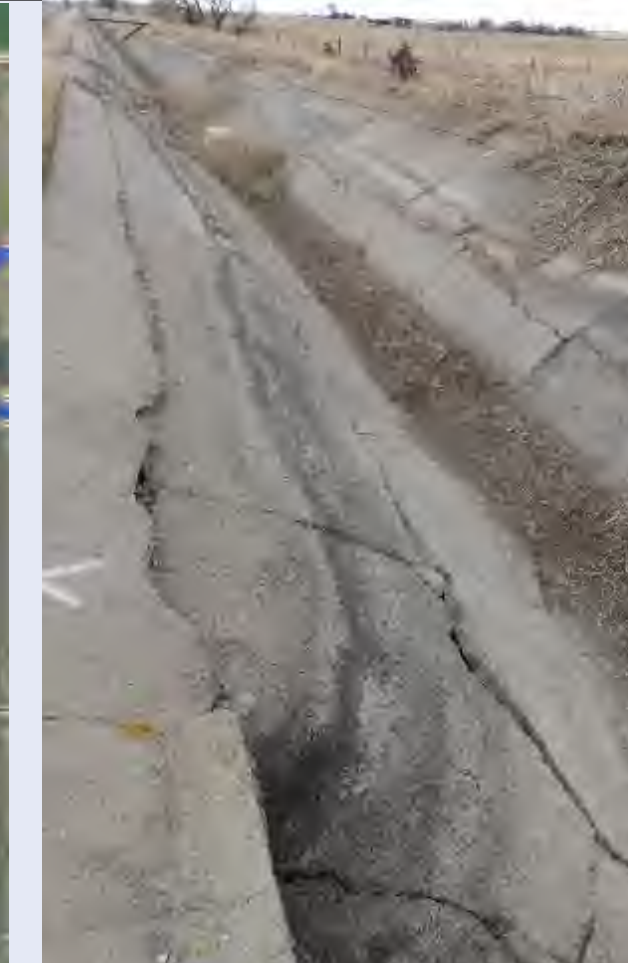
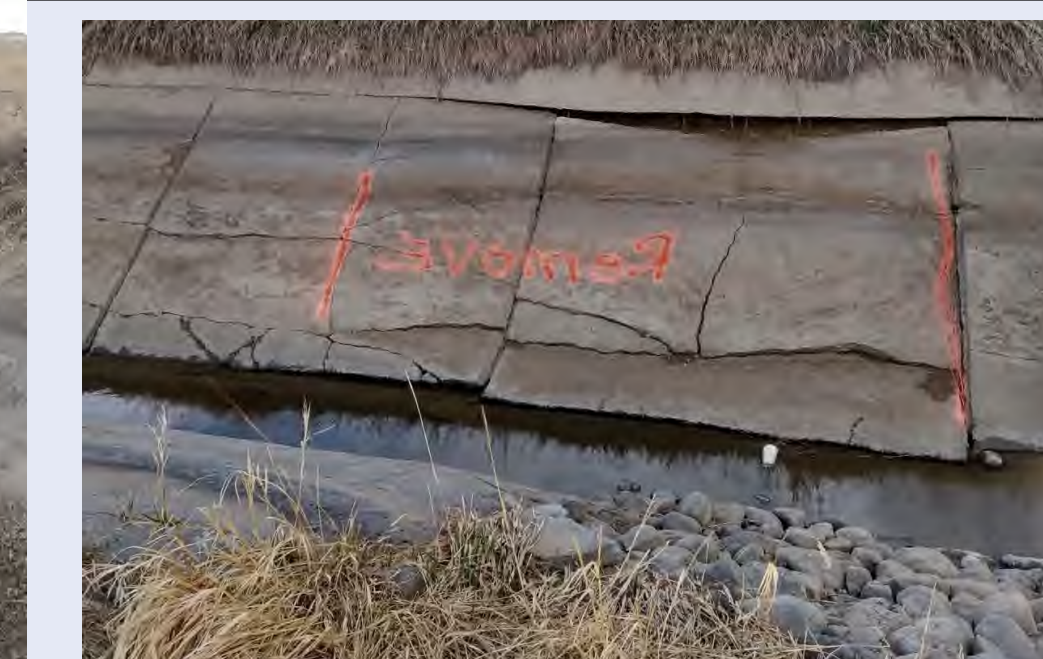
Big Bend Main Canal

- Recognized as a failed technology, concrete lined canals have plagued Southern Alberta's Irrigation Districts since their first conception.
- Anticipated Cost of Concrete Canal Replacement: **\$5 Million**

- Since 2020, SMRID & TID have reduced the total length of concrete lined canals from 51 km to 16 km.
- The remaining concrete lined canals represent a liability to the SMRID and continue to compete for funding.

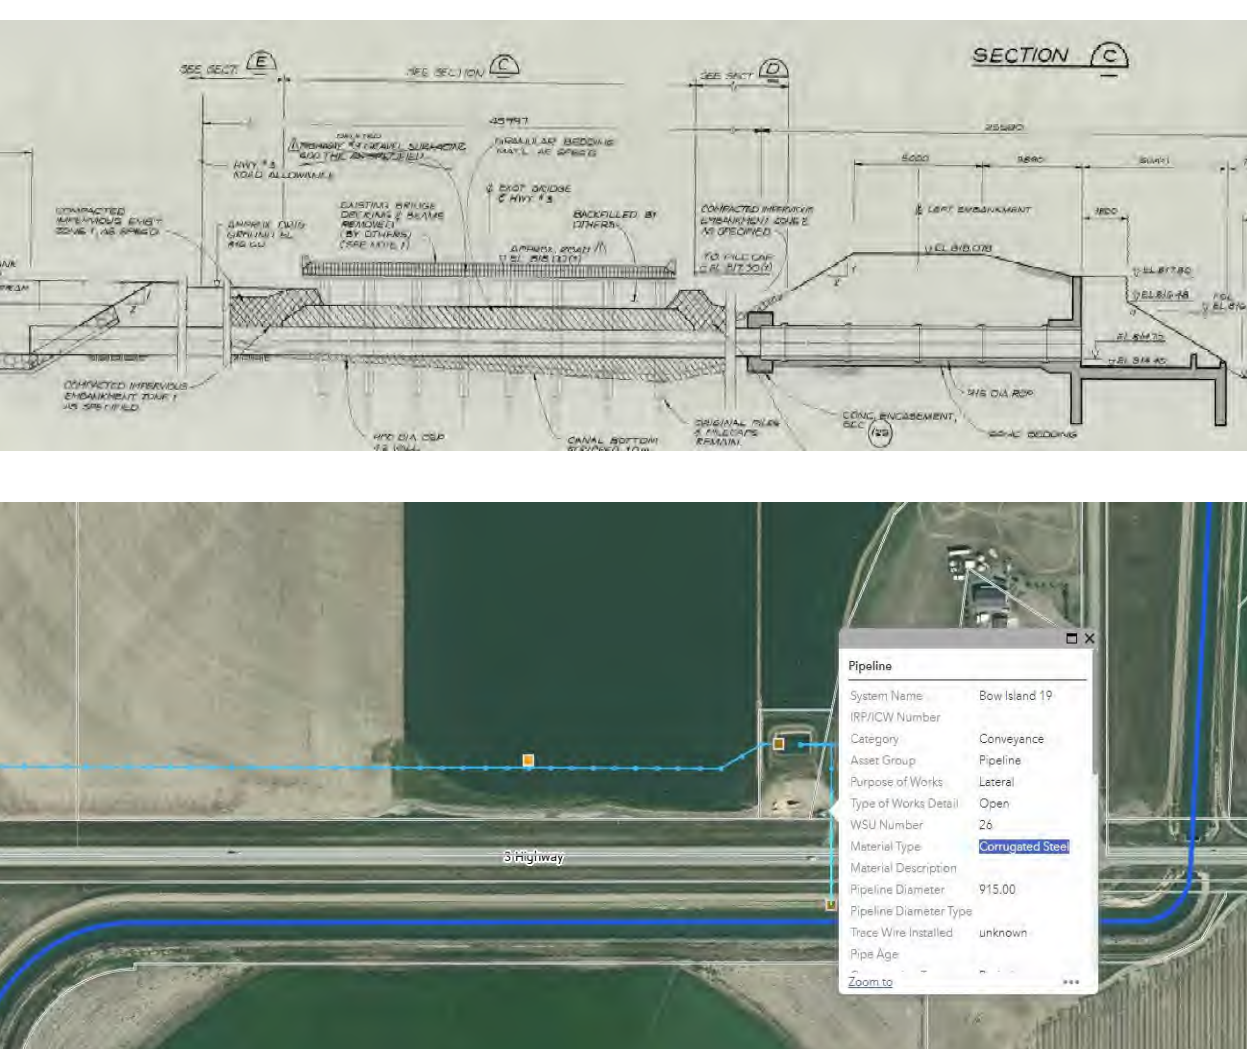
Bow Island 19

- 1988 Construction
- 900 mm Corrugated Steel Pipe
- Flow Rate ~0.2 m³/s, servicing 420 acres.
- CSP crosses underneath HWY 3.

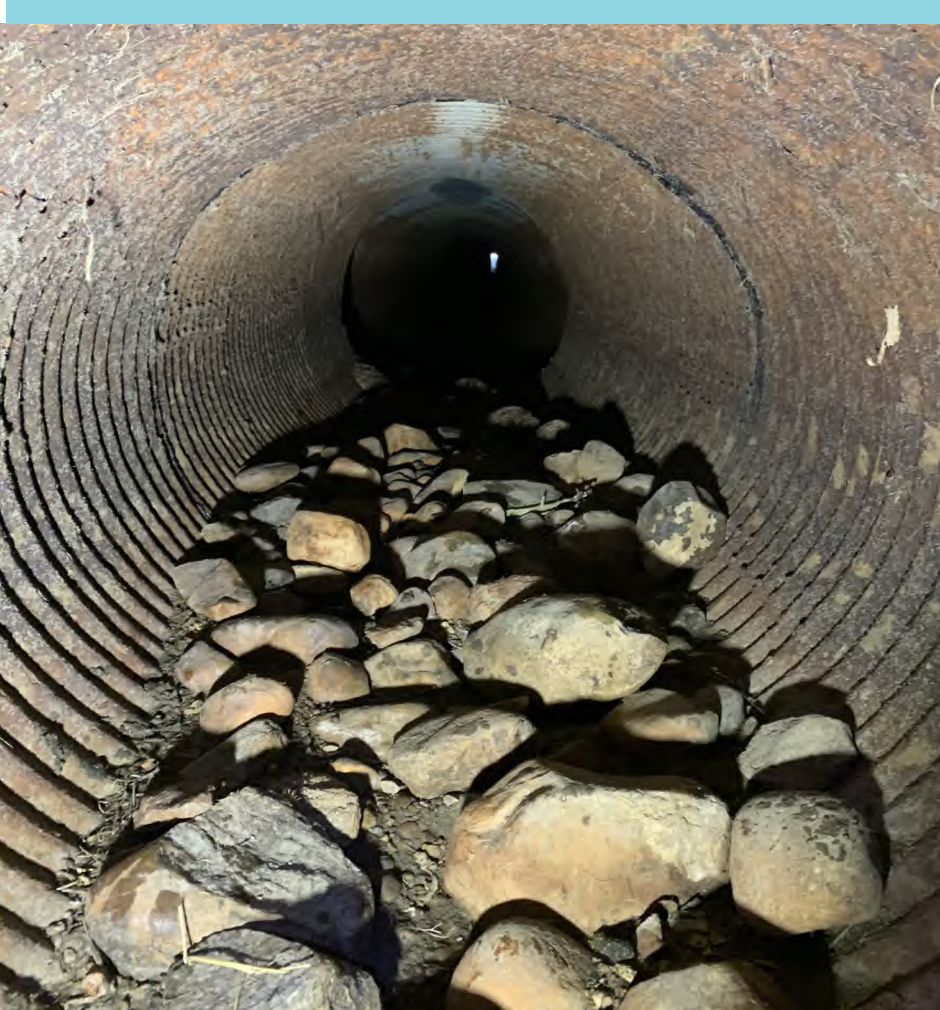
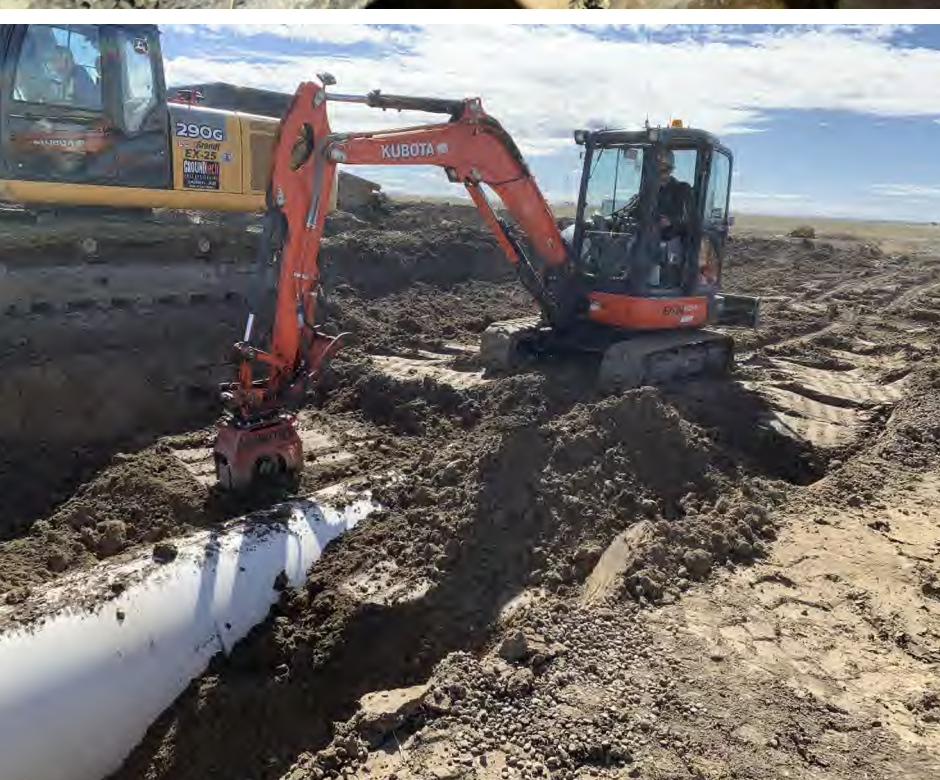
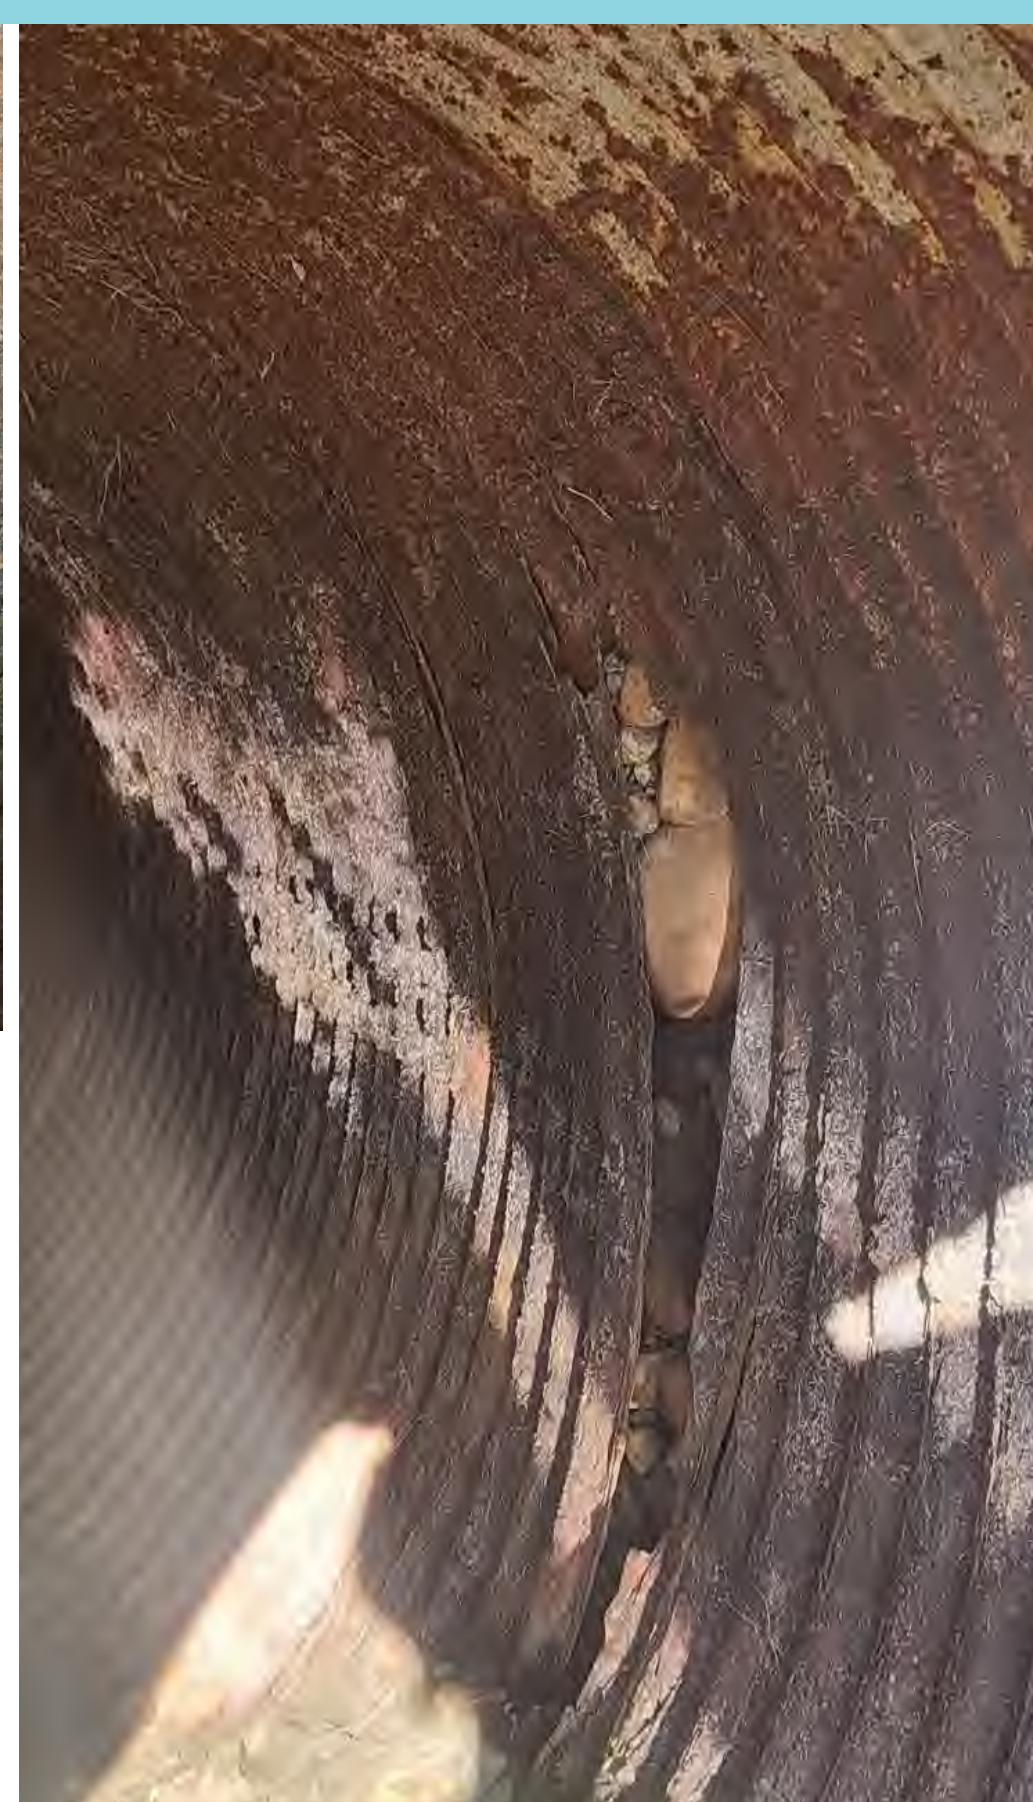
Barnwell 6

- 1981 Construction
- 1500 mm Corrugated Steel Pipe (CSP), 300 m long.
- Flow Rate 1.27 m³/s.
- Seepage; separated joints & penetrations discovered upon shutdown in 2023.
- Removed CSP and replaced with 1200 mm PVC pipe on the same alignment.

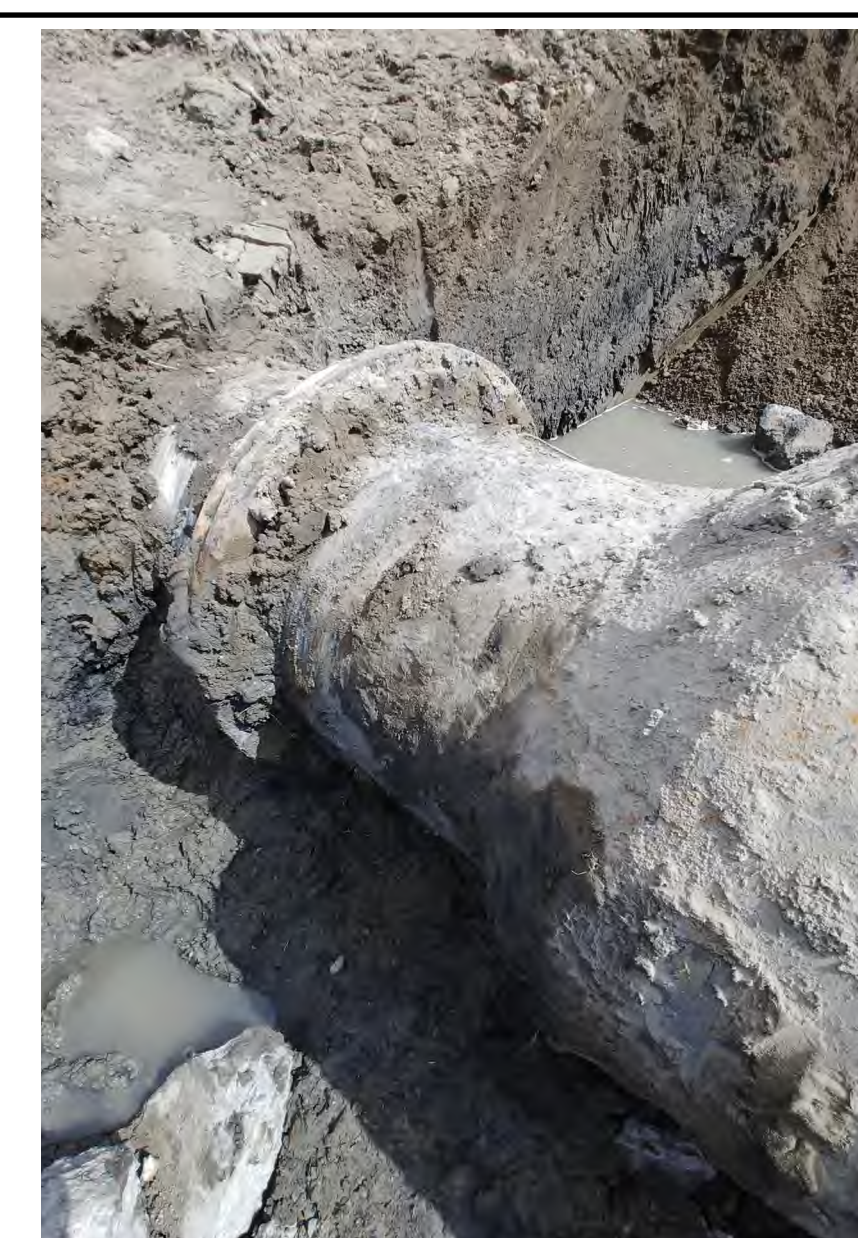
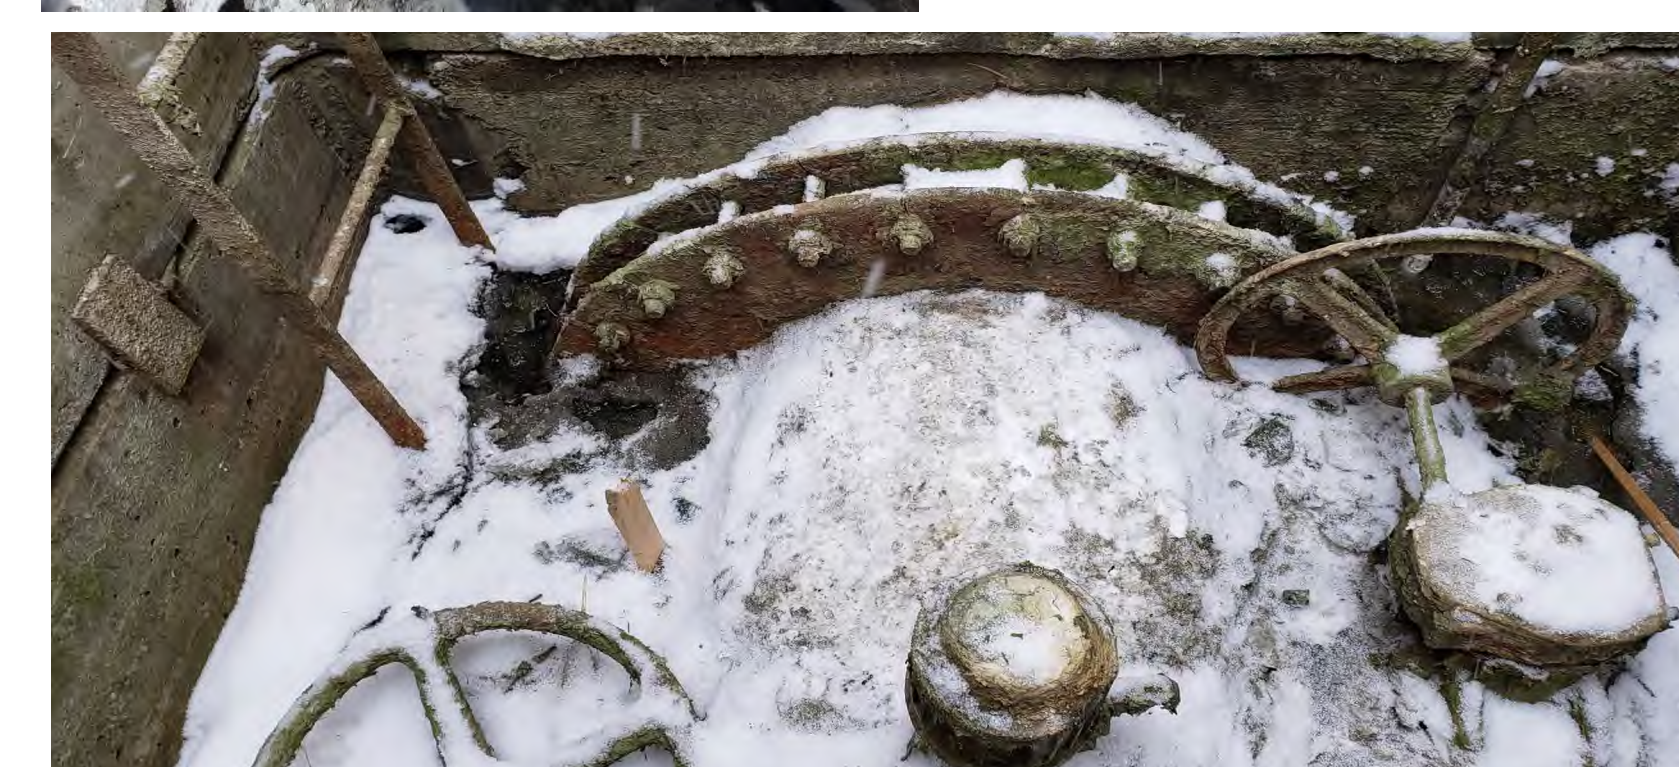
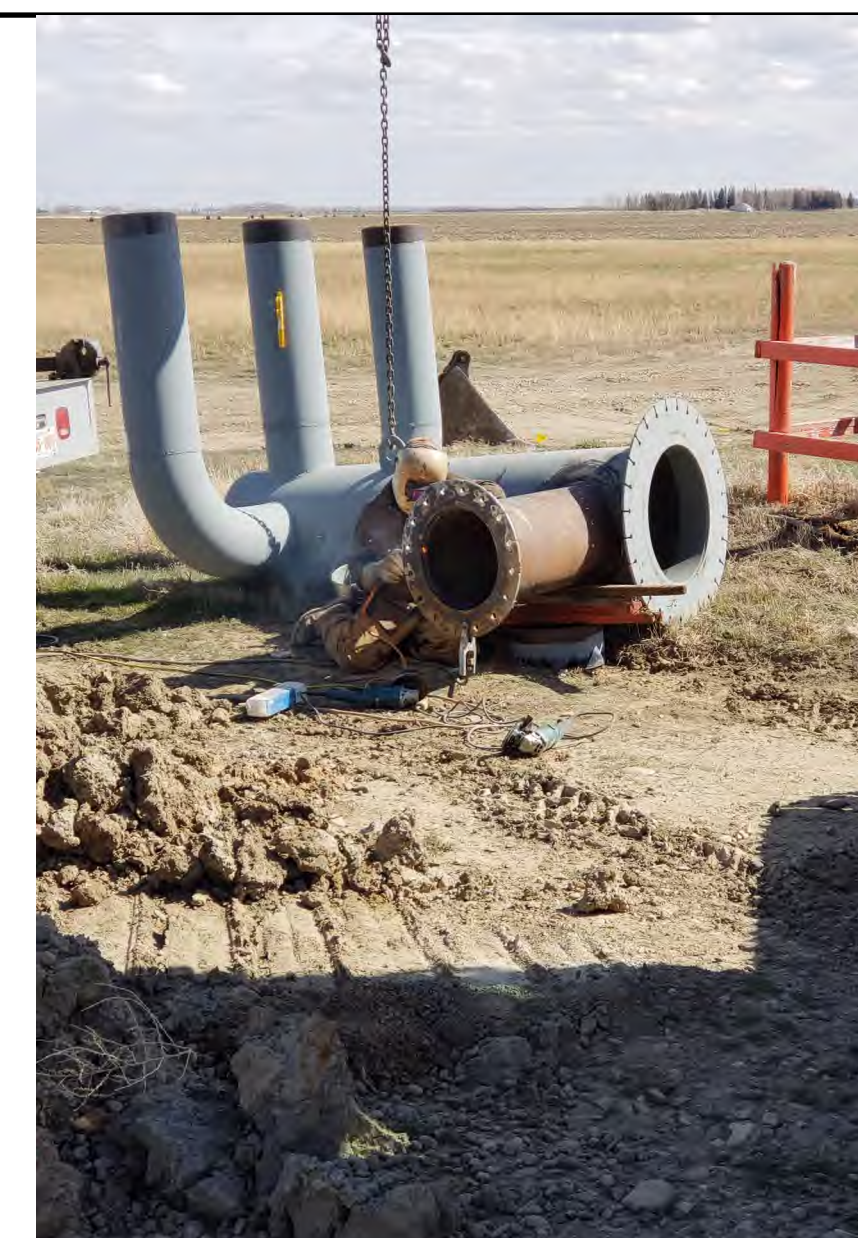
Buried Steel Fittings:

- Numerous buried steel fittings and risers exist in the SMRID.
- Many are approaching the end of their 30-year design and will require replacement.
- Some fittings cannot be replaced by long-lived PVC/HDPE components, and are one-off fabrications with long lead times.

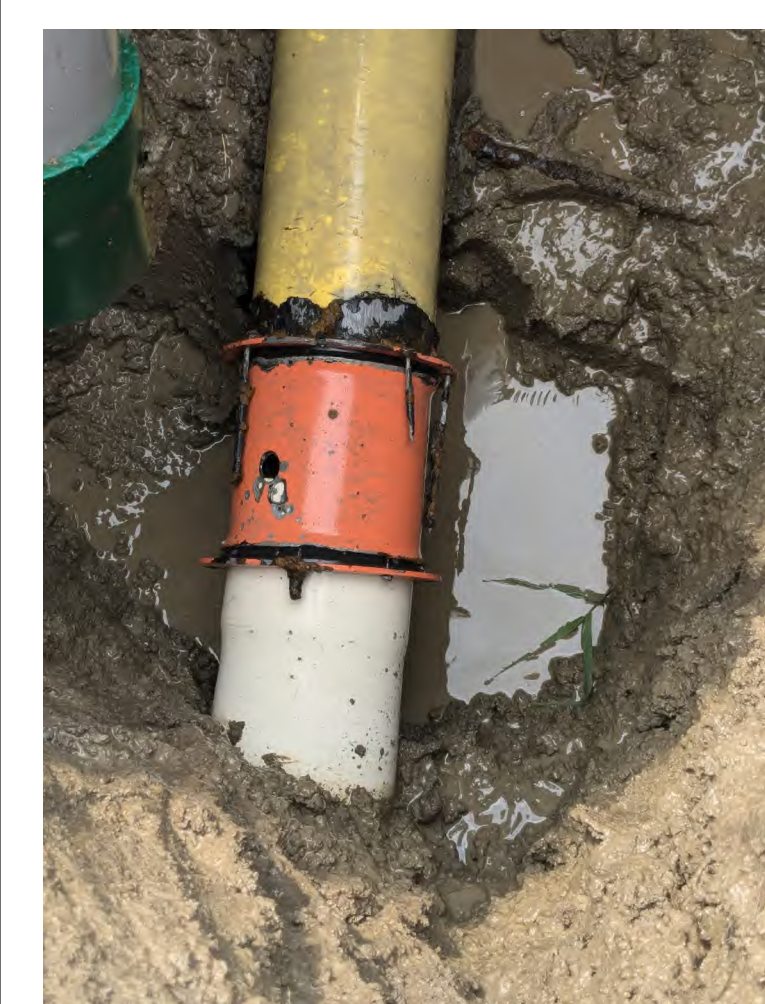
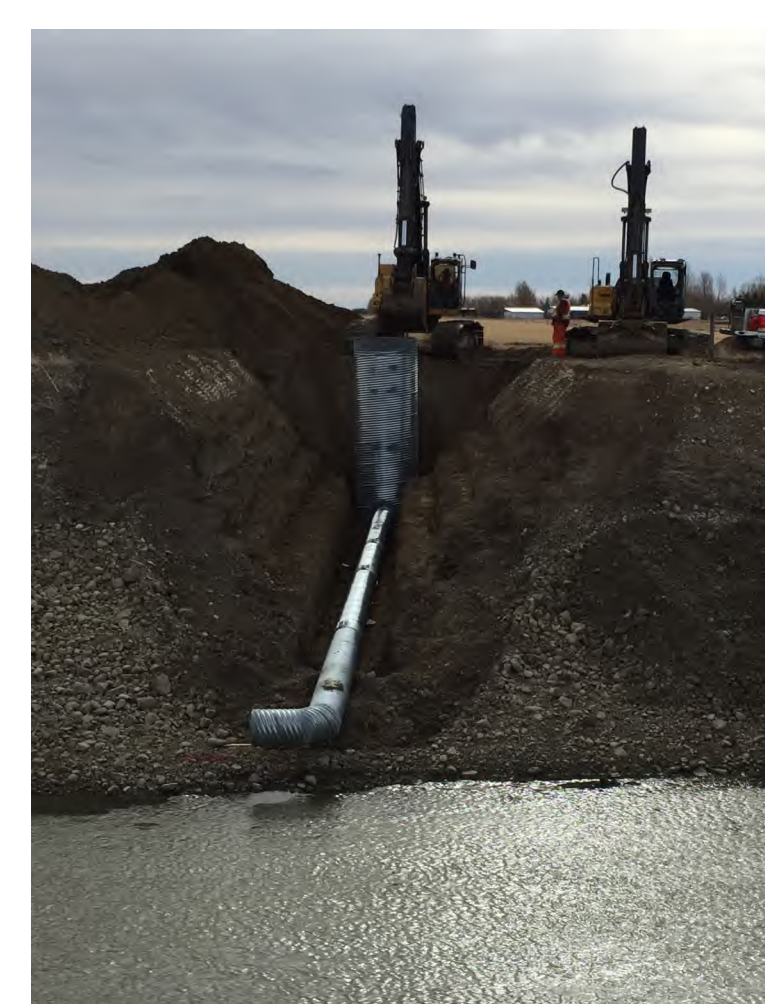
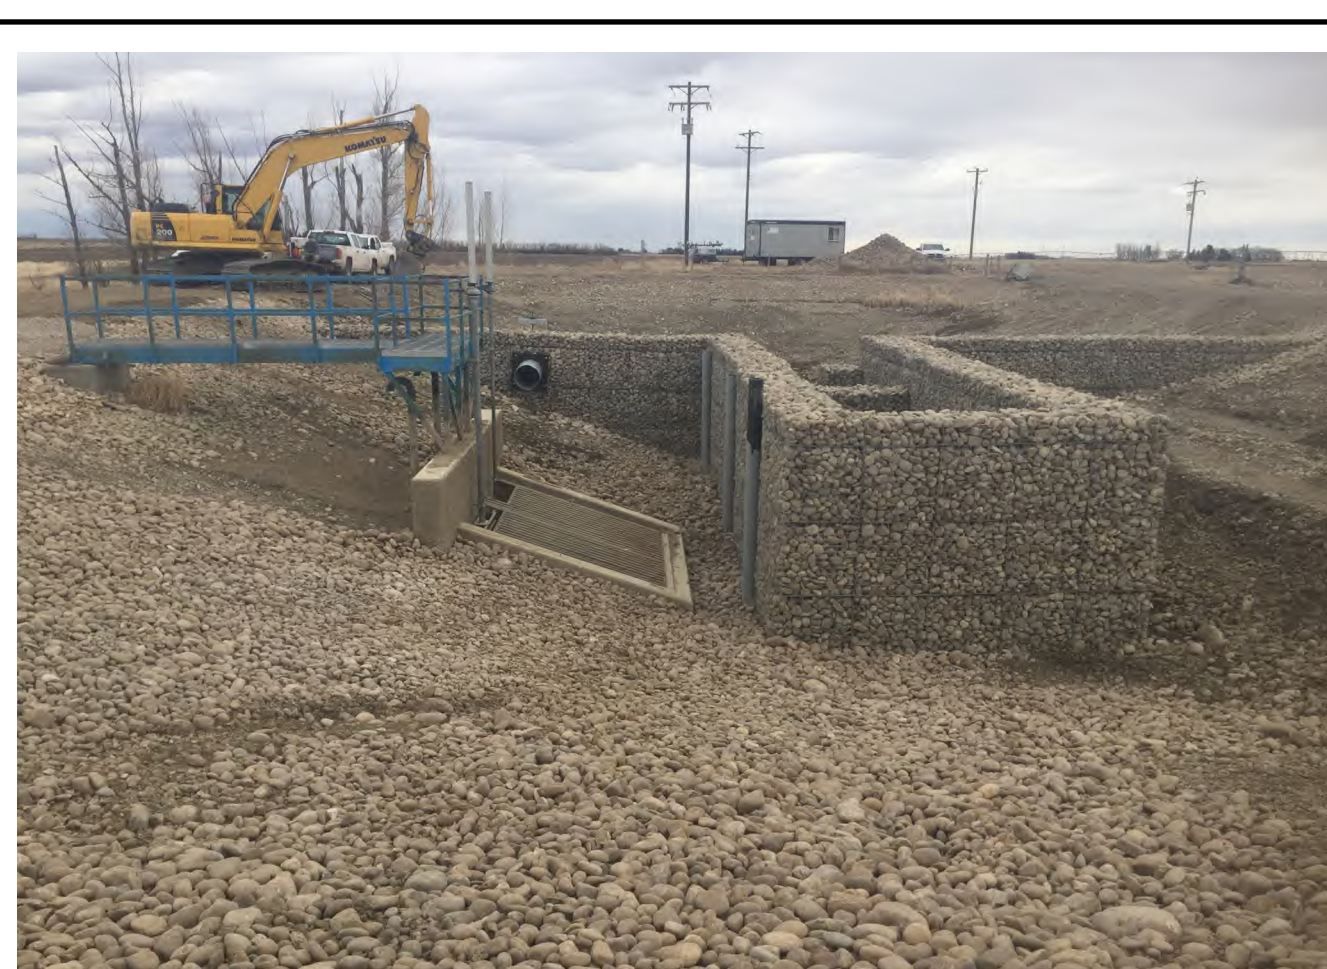
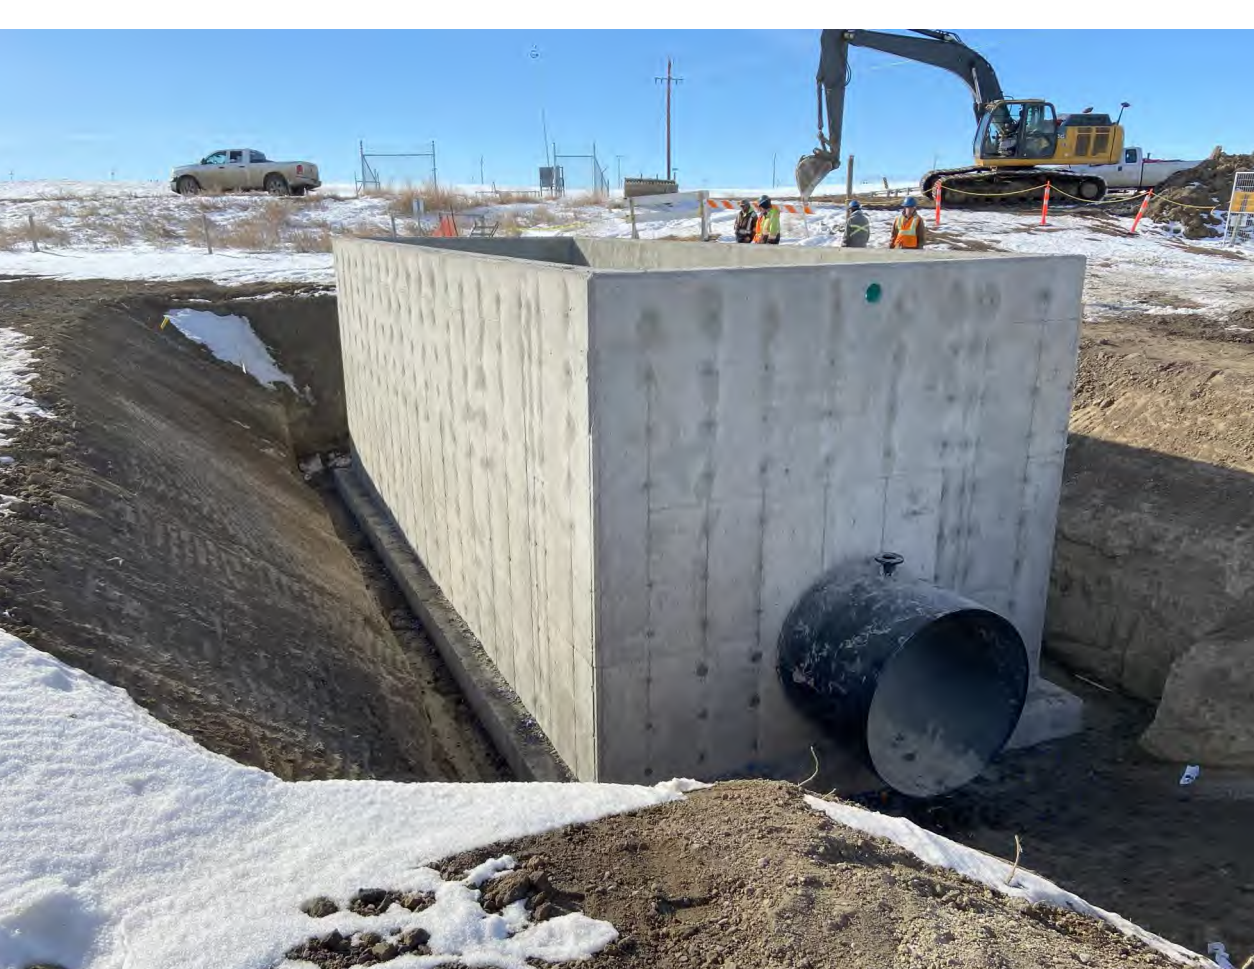
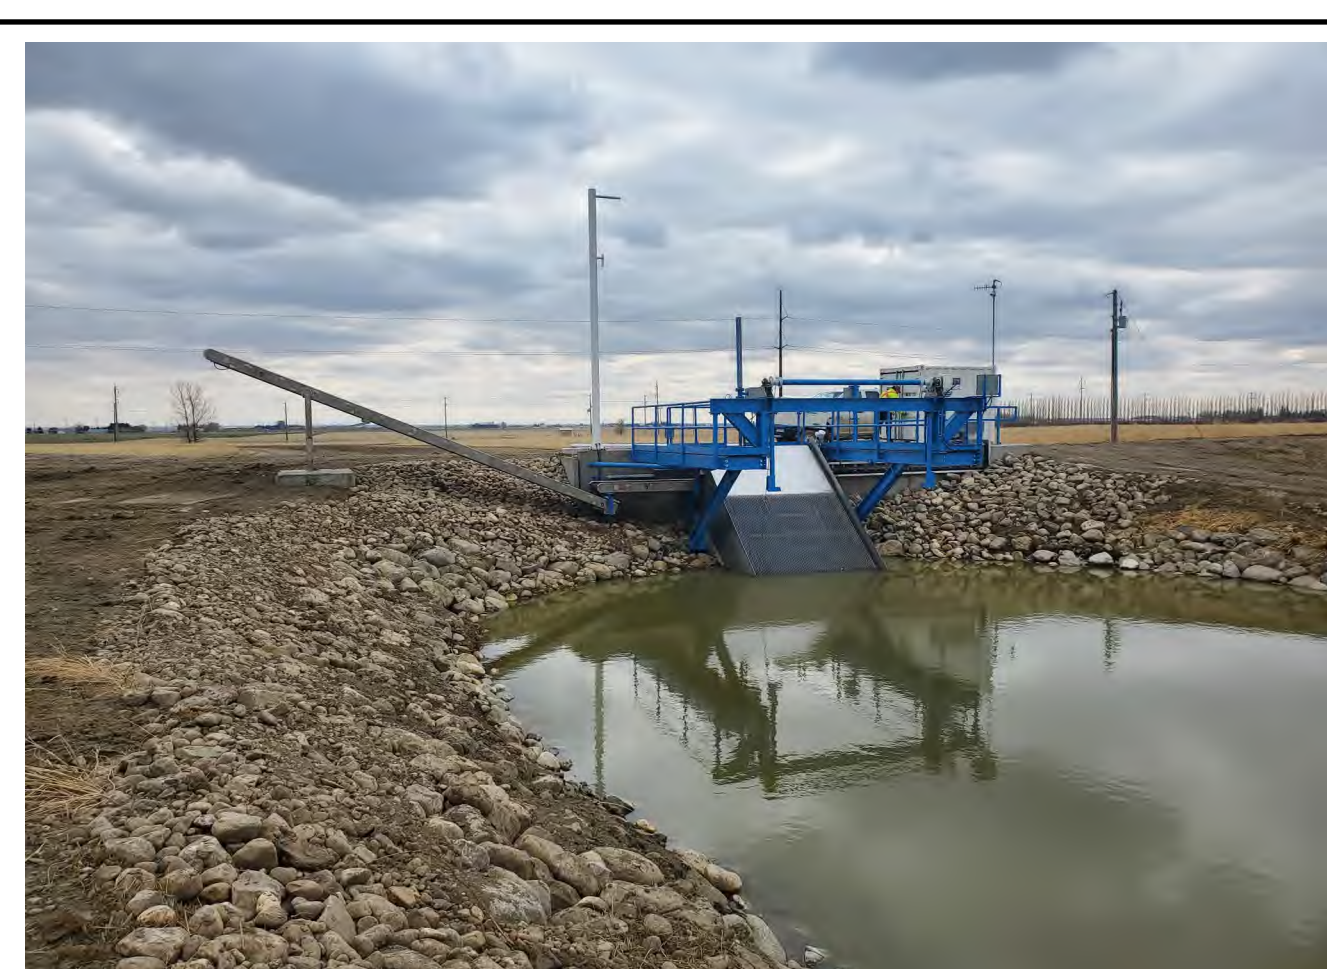
Main Canal Syphons

- Numerous "syphon" turnouts were installed during the Main Canal Rehabilitation of the 1980s.
- Many no longer hold prime, and require replacement to meet service delivery targets.
- Projects are funded by general revenue as it is required.

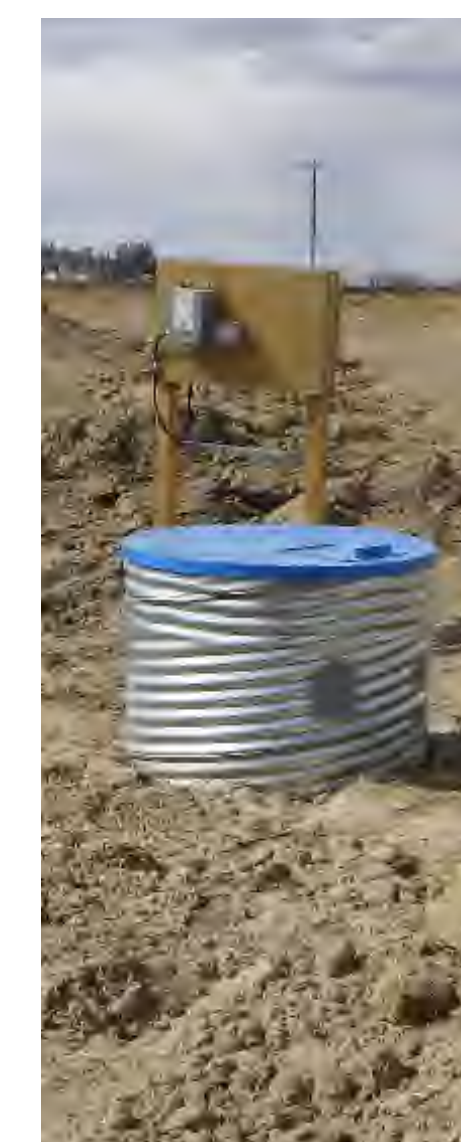
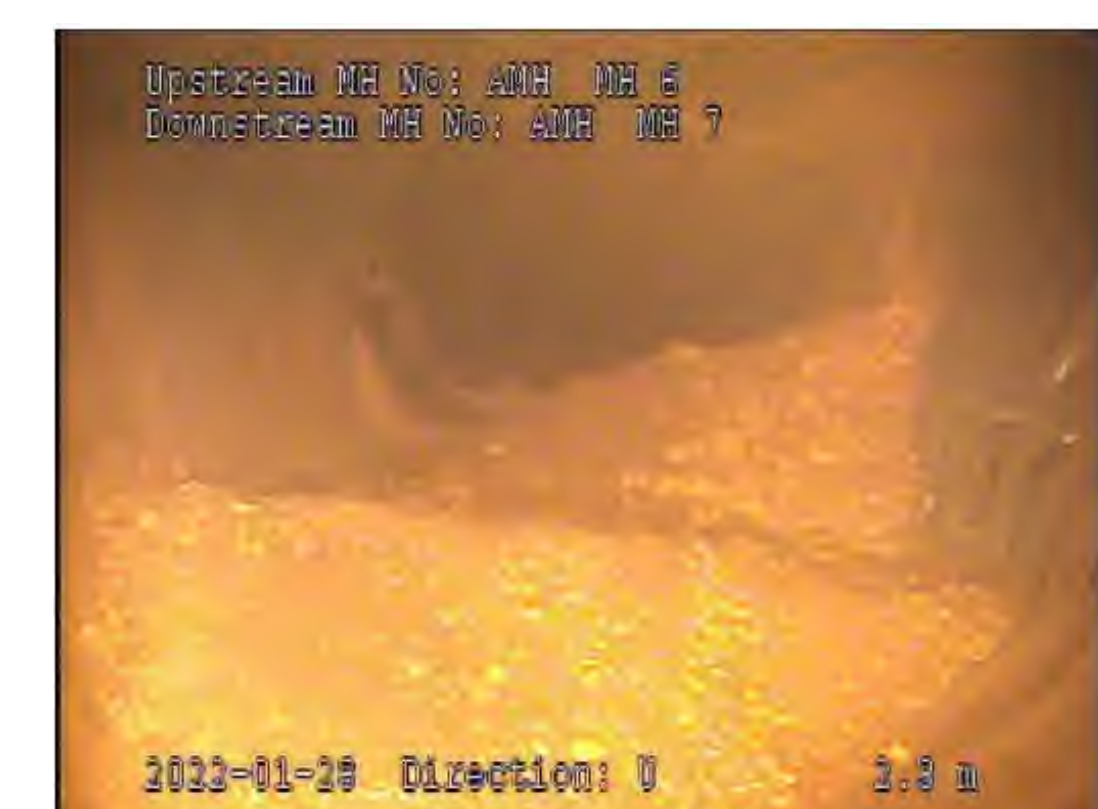
Tile Drains

- It is estimated several hundred km's of buried tile drains exist in the district, which are currently being inventoried.
- Networks were installed in the 1960s thru to 1990s.
- Replacement of steel components and clay pipes are representing a growing liability. **~\$750,000/year to replace**
