# SMRID Infrastructure:

# Main Canal Structure Maintenance:

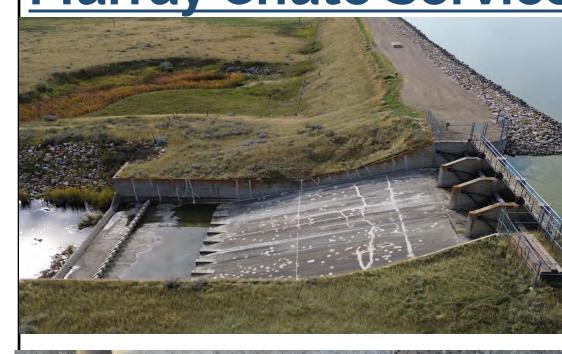
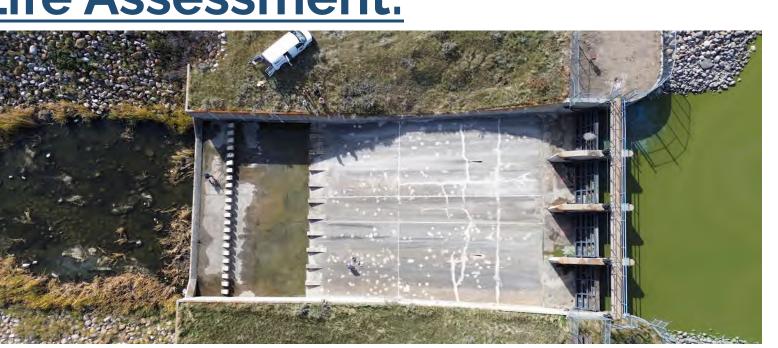
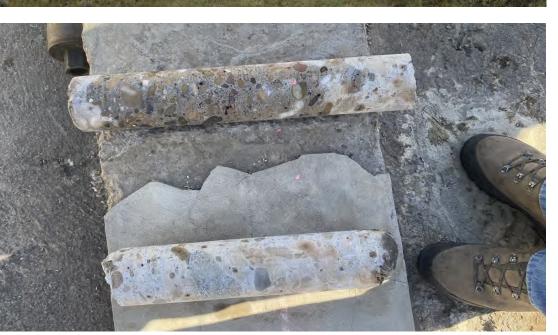
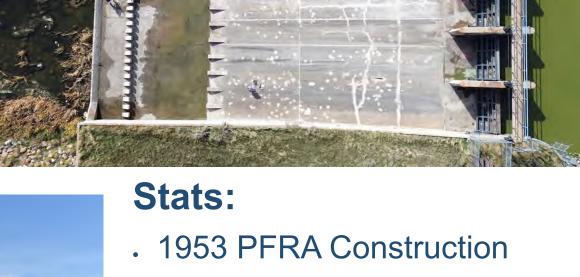
# **Murray Chute Service Life Assessment:**

- 4 Bay concrete chute with a capacity of 225 m<sup>3</sup>/s
- Maintains Murray Reservoir Level during flooding
- Considered to be in "fair to poor" condition

- Investigation conducted by MPE in October 2024
- To be determined
- Cost of Replacement: \$4-5 Million

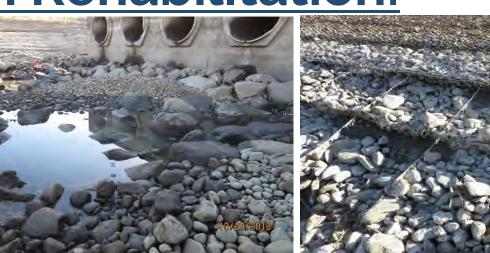
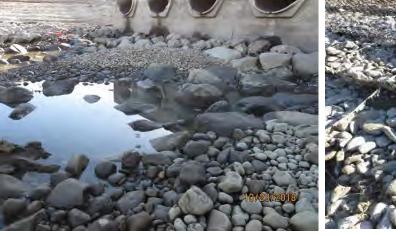
# Stafford Reservoir Outlet Basin Rehabilitation:

- Riprap Basin constructed in 1986 with Stafford Reservoir Development
- Gabion Mattress riprap was selected for costsavings
- Movement of riprap and deterioration of gabions
- **Total Cost of Replacement \$400,000**

- 900 mm riprap from the Crowsnest Pass hauled to site Design Life: 50 years
- Contractor: TBD
- Rehabilitation of outlet basin underway in 2025
- ~\$350,000

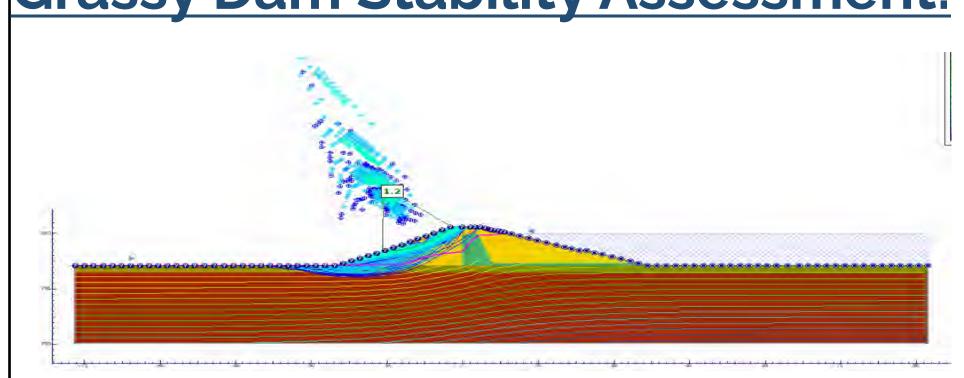
# **Grassy Dam Stability Assessment:**

The 2024 Dam Safety Review identified the downstream slope has a factor of safety of 1.2; should be at minimum, 1.5

- Drilling investigation planned for 2025 to evaluate stability of the dam ~\$150,000
- Resulting rehabilitation could range up to \$2-3 Million
