North Burdett

Remaining Concrete Canals

Buried Steel Components of Pipelines

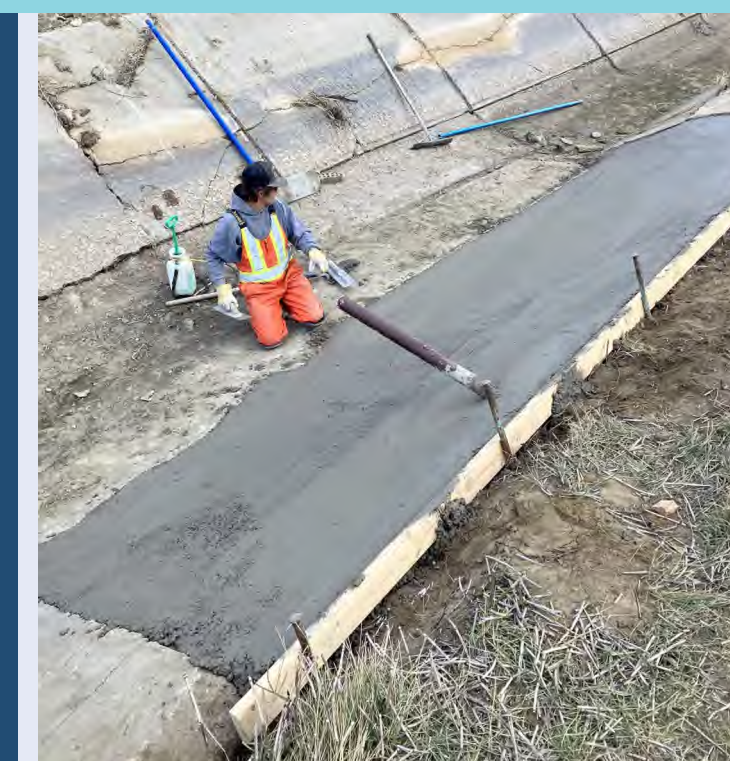
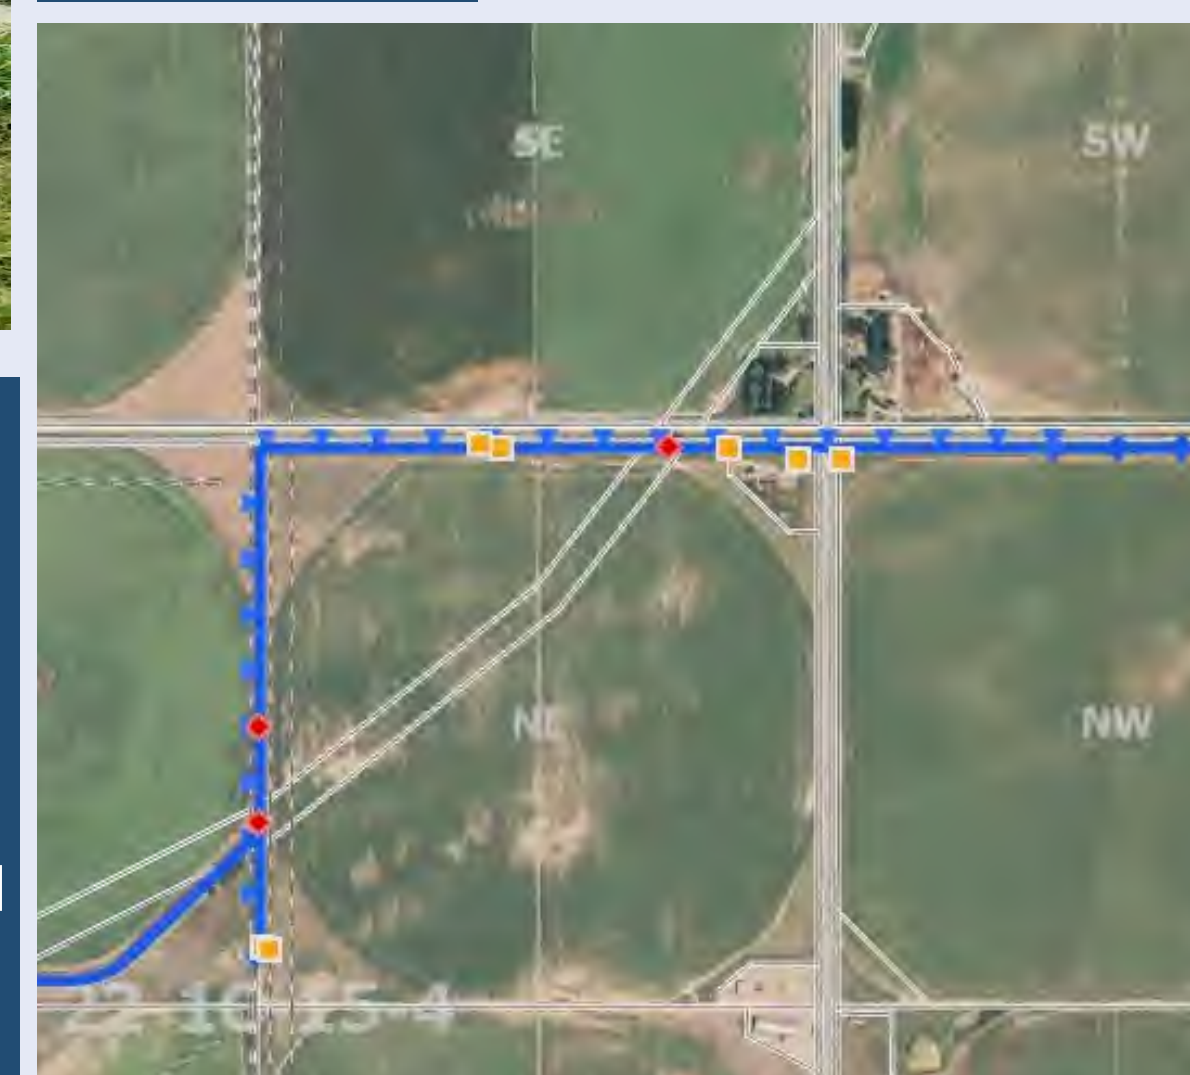
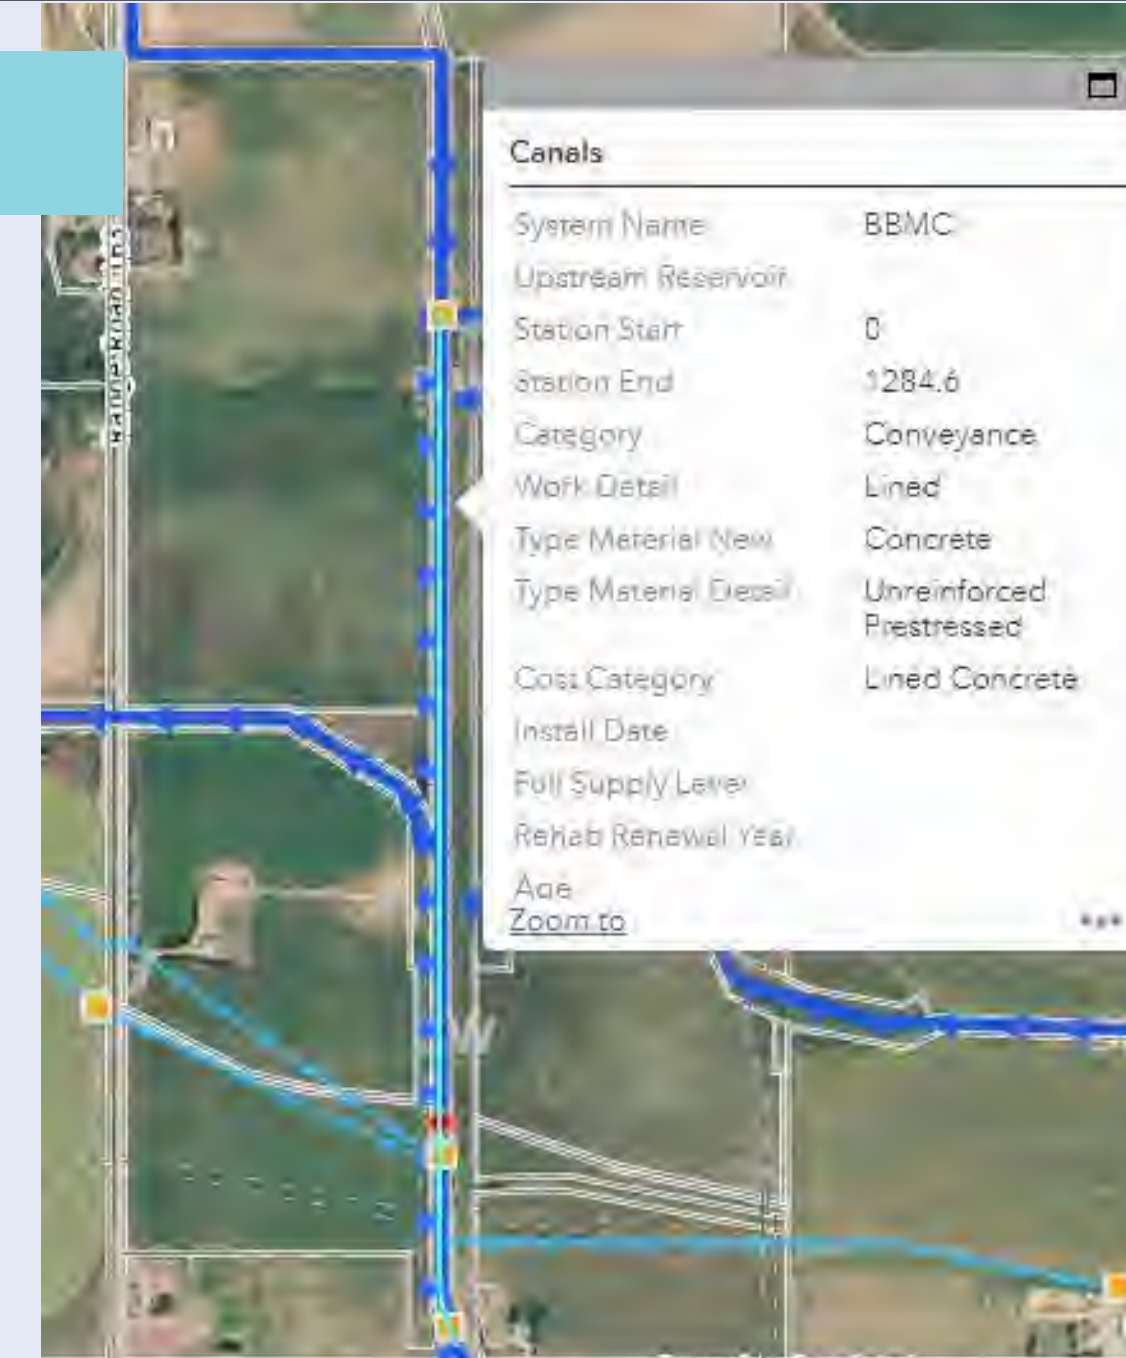
Stats:

- Recognized as a failed technology, concrete lined canals have plagued Southern Alberta's Irrigation Districts since their first conception.
- Anticipated Cost of Concrete Canal Replacement: **\$5 Million**

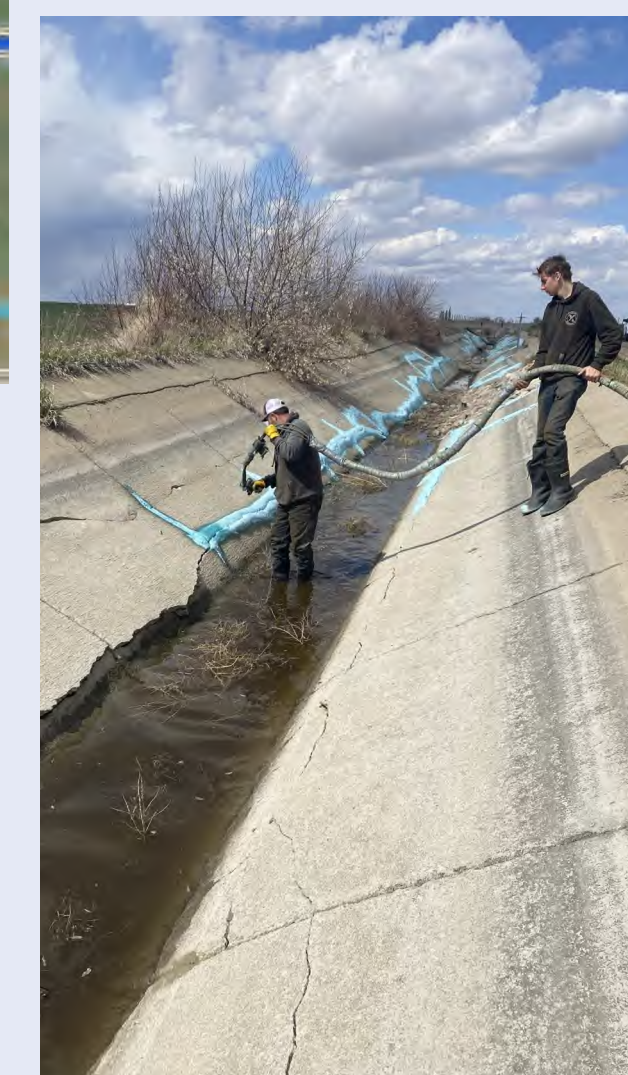
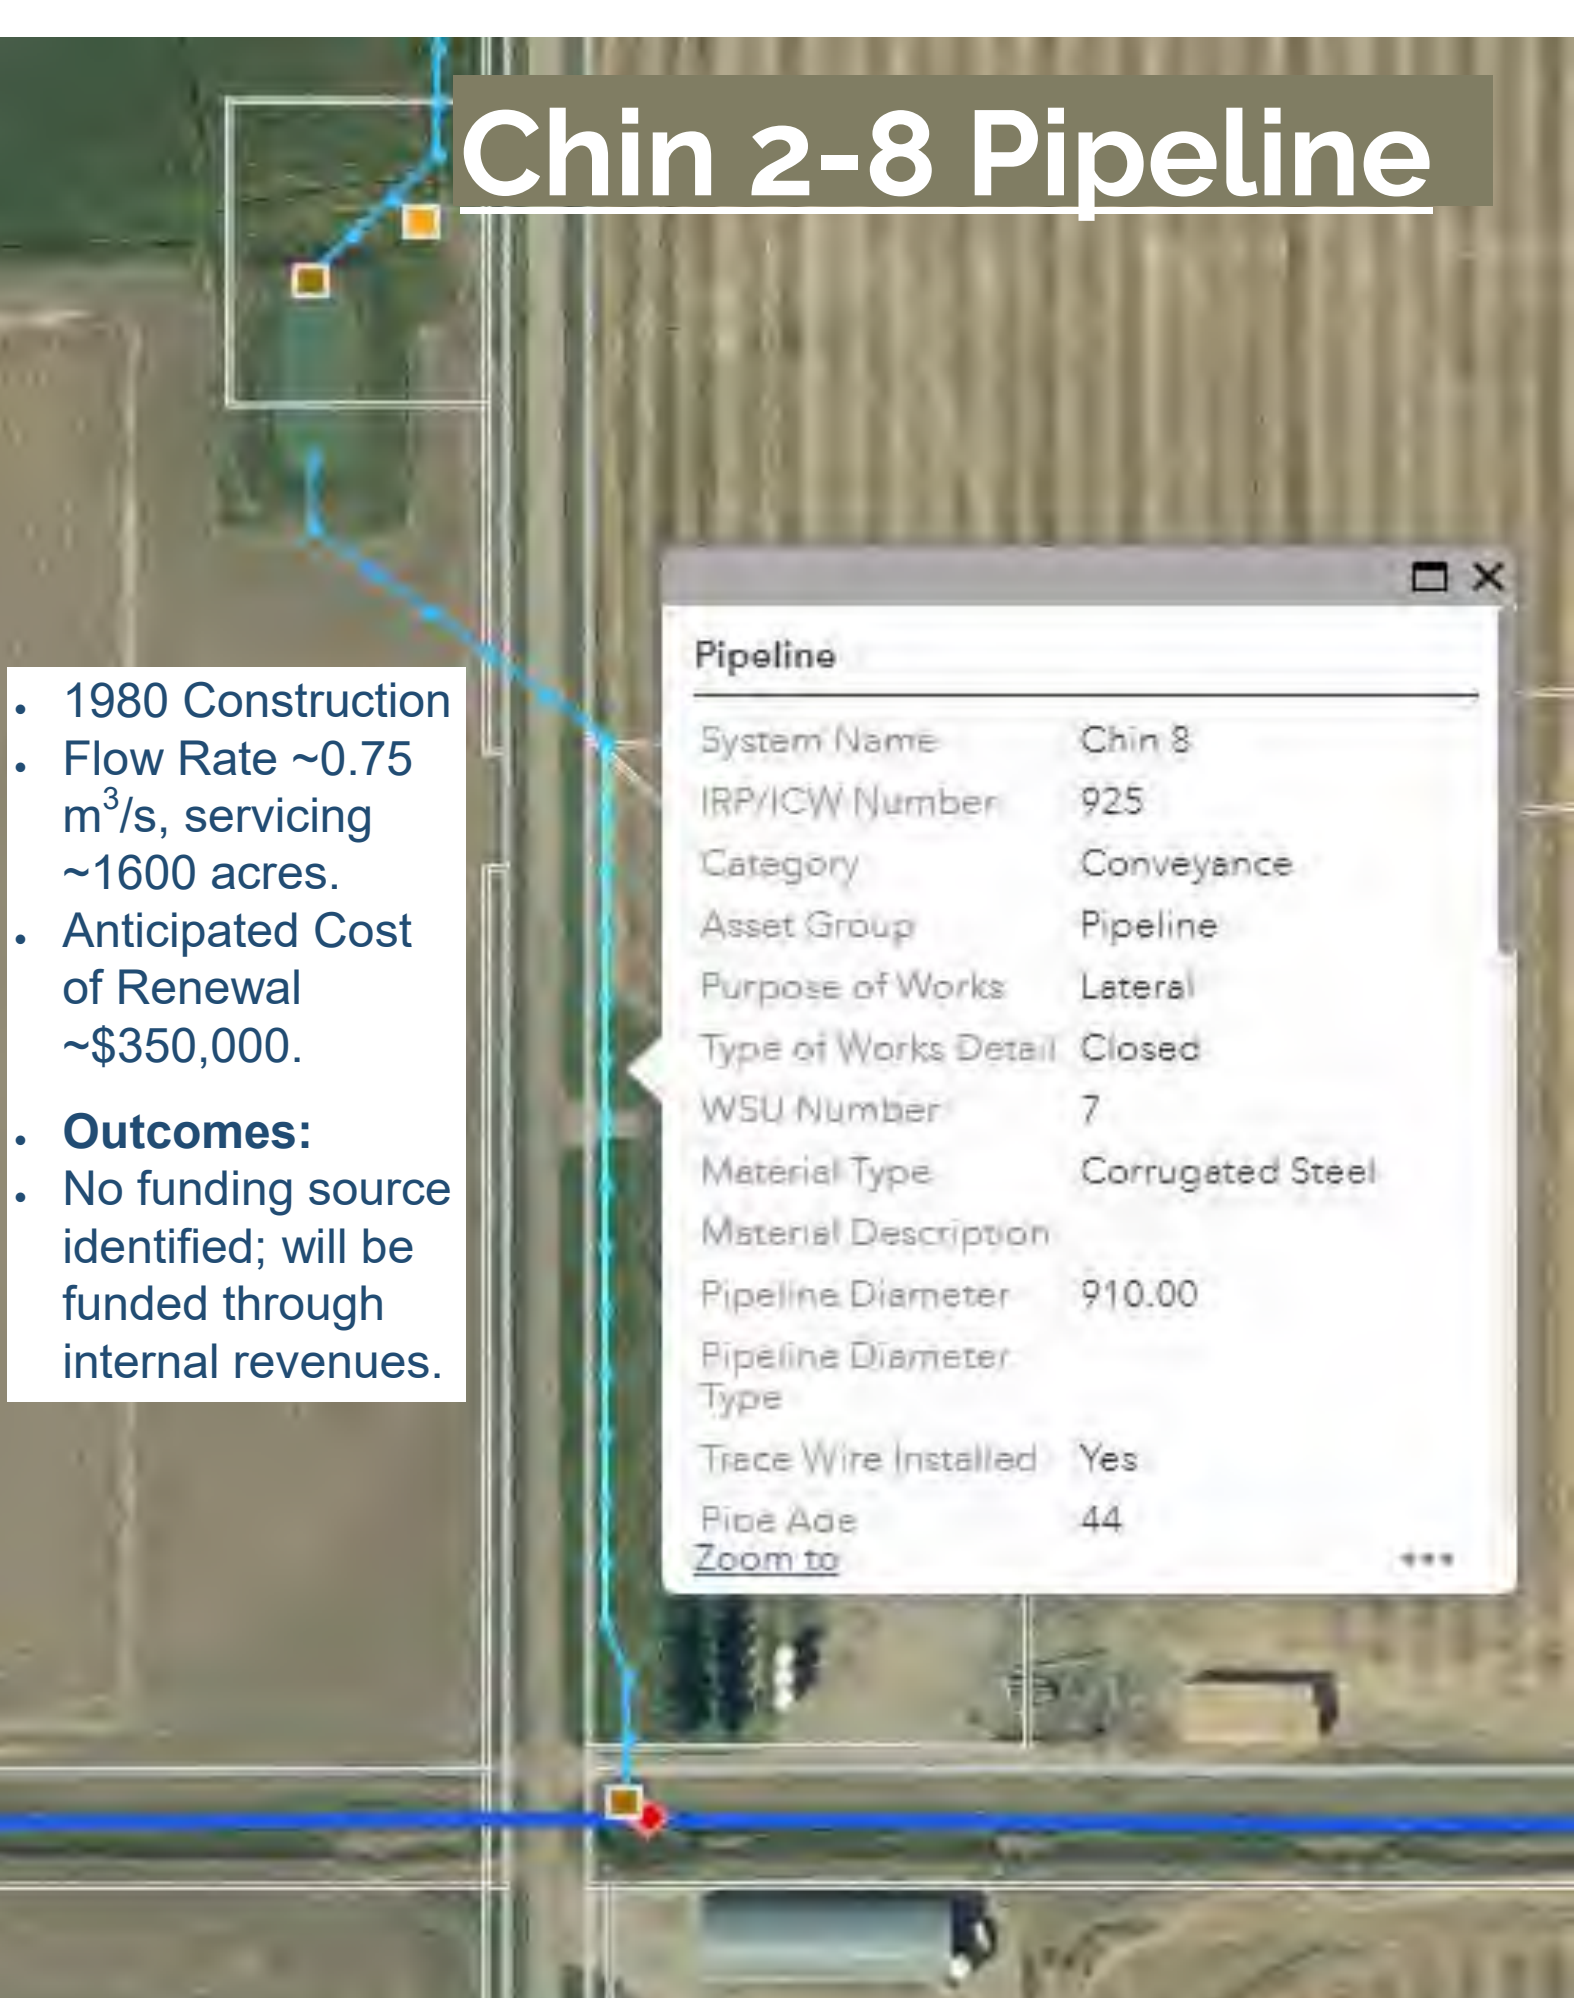
Bow Island 19

- 1980 Construction
- Flow Rate ~0.75 m³/s, servicing ~1600 acres.
- Anticipated Cost of Renewal ~\$350,000.
- Outcomes:
- No funding source identified; will be funded through internal revenues.

Pipeline	
System Name	Chin 8
IRP/CW Number	925
Category	Conveyance
Asset Group	Pipeline
Purpose of Works	Lateral
Type of Works Detail	Closed
WSU Number	7
Material Type	Corrugated Steel
Material Description	
Pipeline Diameter	910.00
Pipeline Diameter Type	
Tiece Wire Installed	Yes
Pics Acc	44
Zoom In

- 1988 Construction
- 900 mm Corrugated Steel Pipe
- Flow Rate ~0.2 m³/s, servicing 420 acres.
- CSP crosses underneath HWY 3.

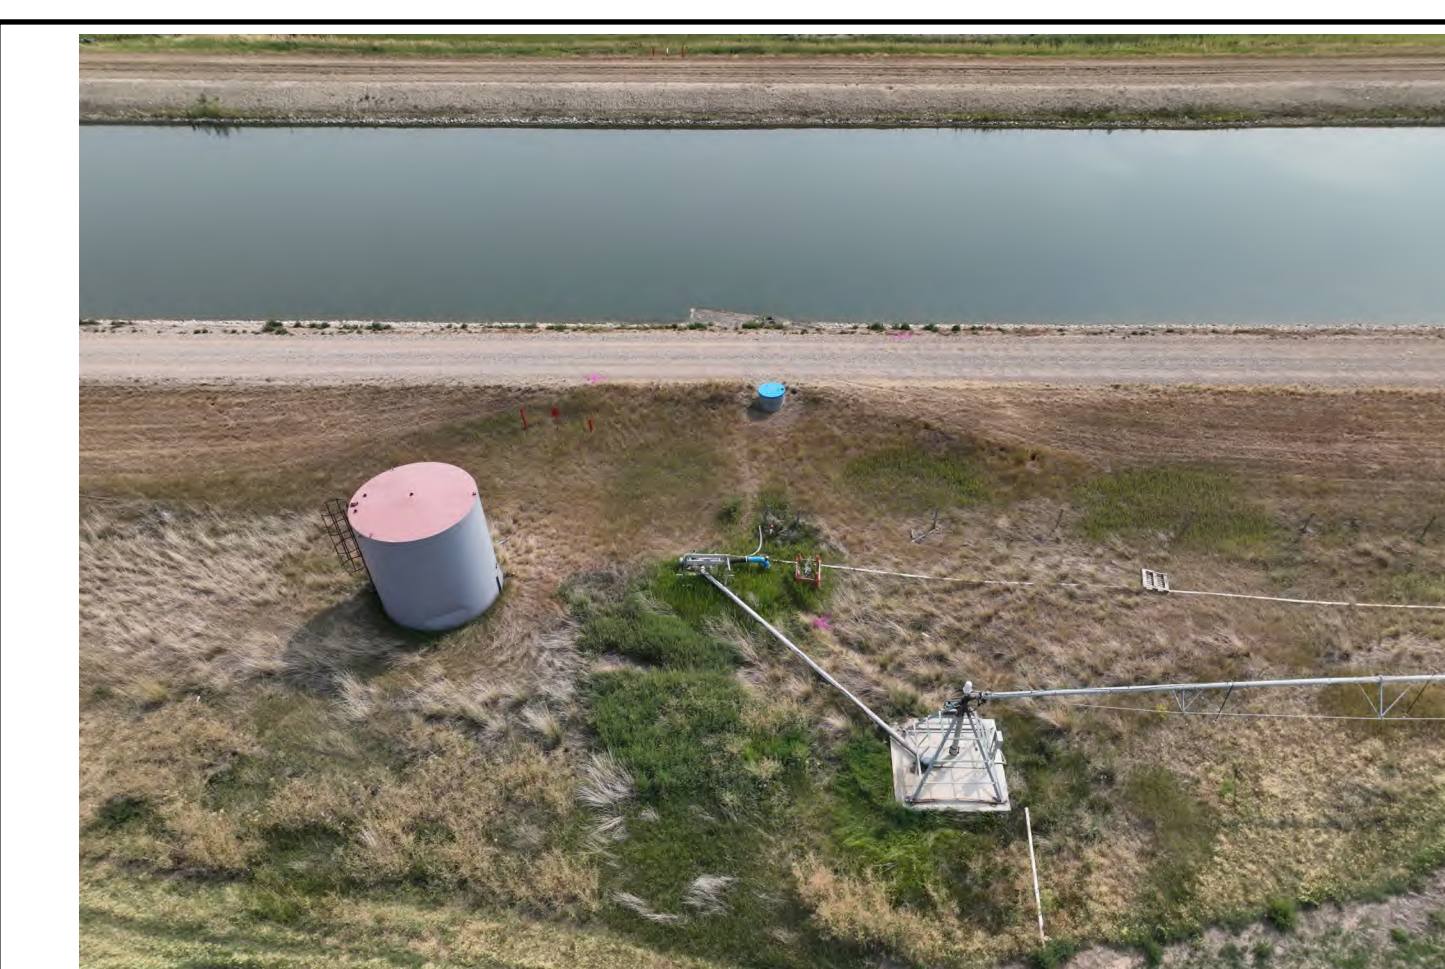
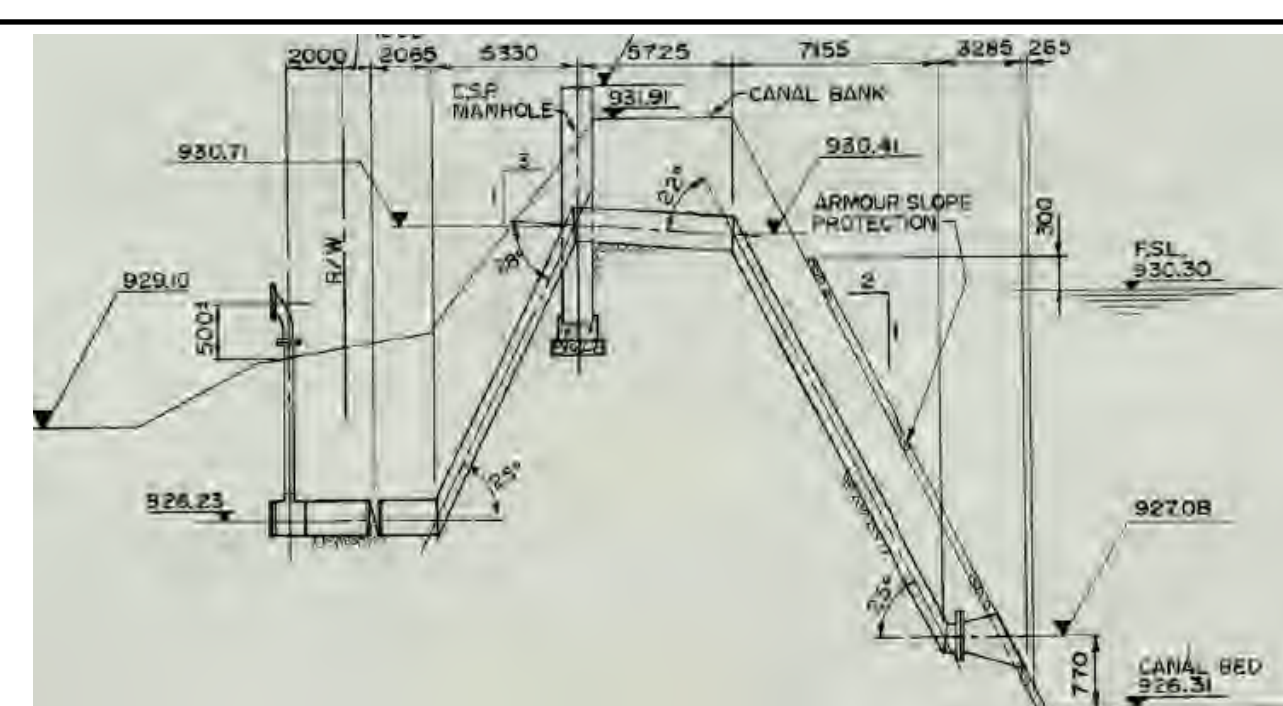
Main Canal Syphons

- Numerous "syphon" turnouts were installed during the Main Canal Rehabilitation of the 1980s.
- Many no longer hold prime, and require replacement to meet service delivery targets.
- Projects are funded by general revenue as it is required.

Each replacement costs ~\$65,000.

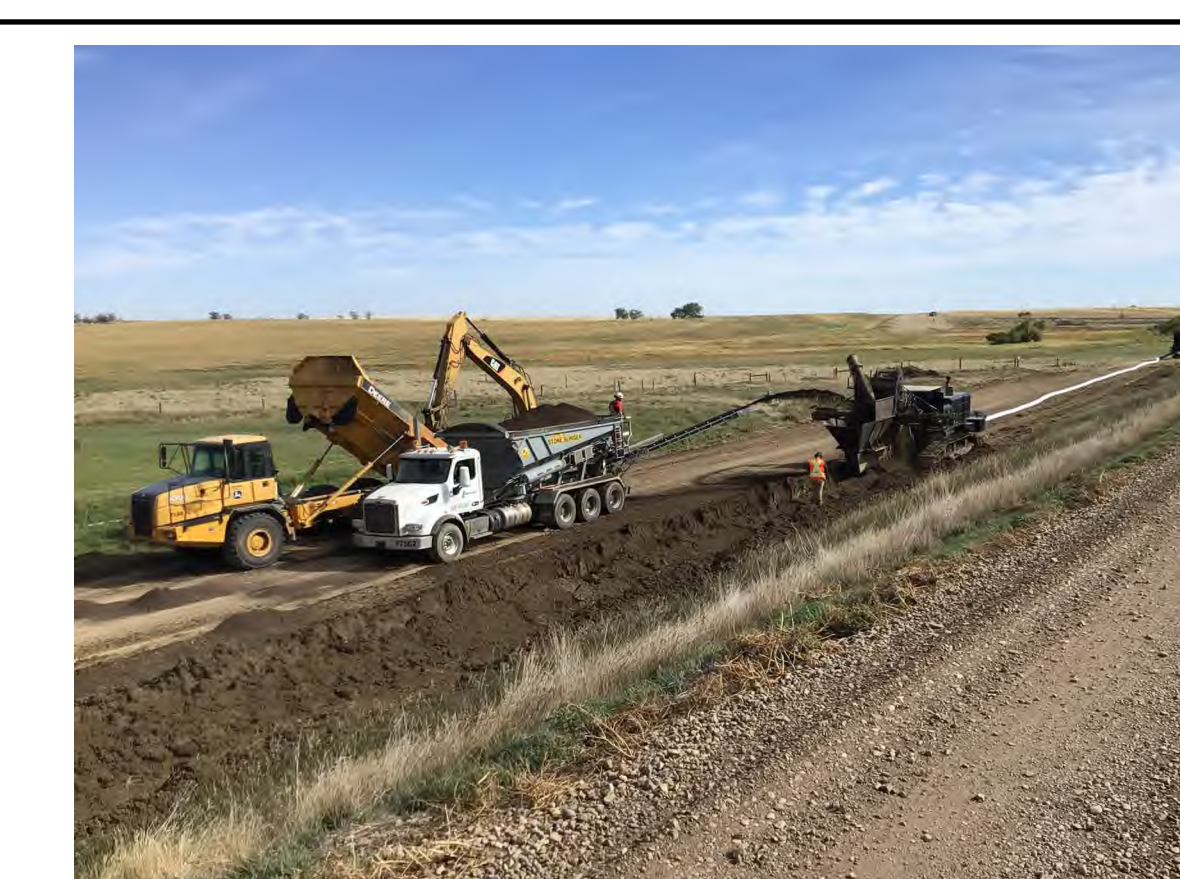
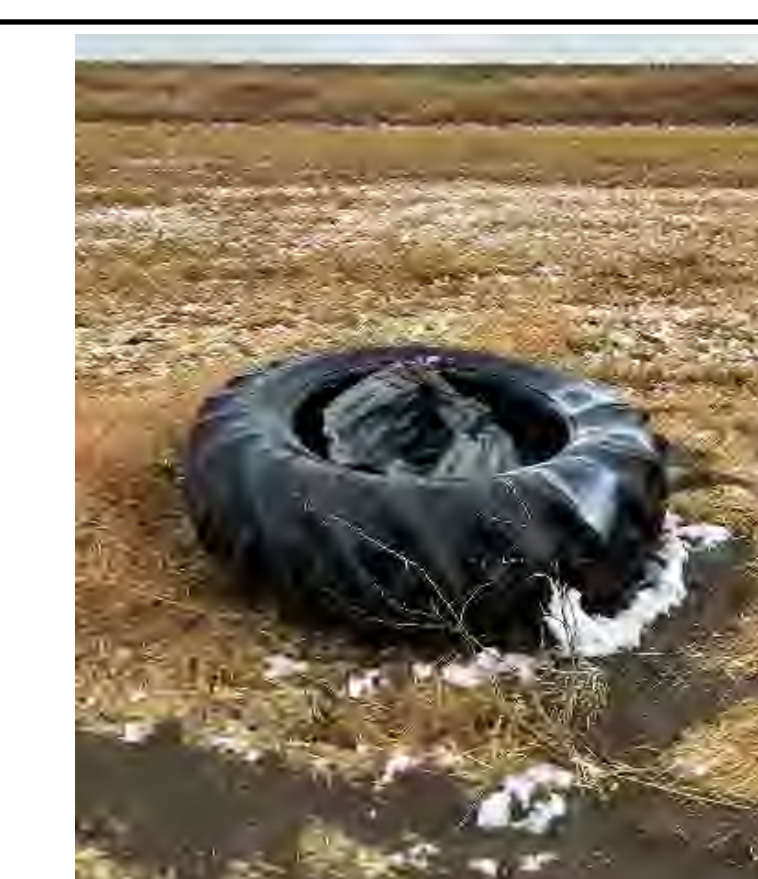
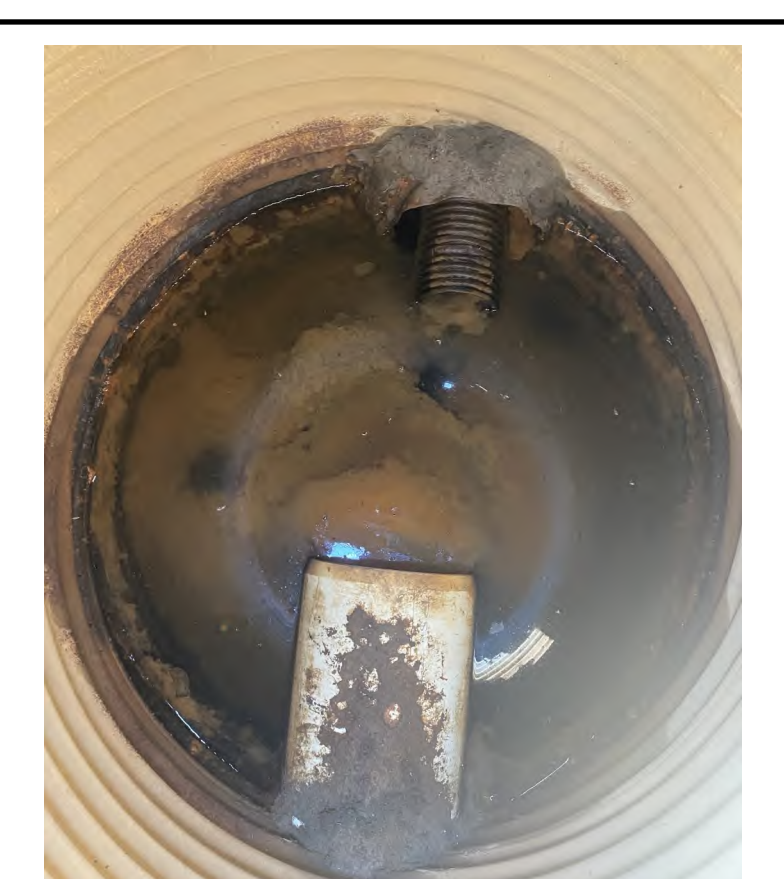
Tile Drains

- It is estimated several hundred km's of buried tile drains exist in the district, which are currently being inventoried.
- Networks were installed in the 1960s thru to 1990s.
- Replacement of steel components and clay pipes are representing a growing liability. **~\$750,000/year to replace**
